## Peer Review

Review of Comprehensive Heritage Study Proposed

Cumberland Heritage List – Westmead Only

Cumberland City Council

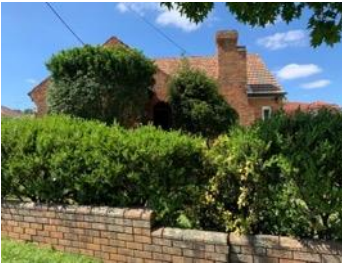
<p>HS89(2)</p>

Item	Name	Address	Listing	Comments	Recommendations	Photographic Evidence
HS89	Post-war Bungalow	30 Alexandra Street	Local	<p>Heritage Inventory Sheet has detailed historical information and description of physical condition. The assessment of significance is thorough.</p> <p>The residence was built in an architectural style that is distinguishable from existing and potential heritage items or contributory items within the immediate vicinity of Westmead HCA.</p> <p>The residence is constructed in red brick masonry which carries a high degree of craftsmanship represented in the use of stretcher bond brick course work to chimney and front façade.</p> <p>Condition: Good</p> <p>Integrity: High</p>	<p>Include NSW themes into inventory sheet.</p> <p>30 Alexandra Ave, Westmead is <b>worthy of listing as an individual heritage item</b>, as identified under Criteria Assessment A) Historic, C) Aesthetic/Technical and G) Representativeness</p>

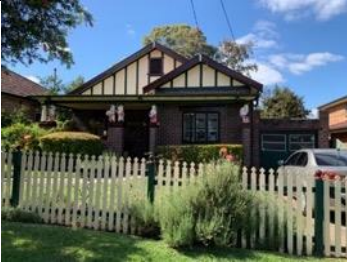
Item	Name	Address	Listing	Comments	Recommendations	Photographic Evidence
HS90	Inter-war Bungalow	18 Austral Avenue	Local	<p>Heritage Inventory Sheet has detailed historical information and description of physical condition. The assessment of significance is thorough.</p> <p>No. 18 Austral Ave Westmead was constructed in the Inter-War Bungalow style.</p> <p>Condition: Good</p> <p>Integrity: Moderate</p>	<p>The residence can be identified as another period of construction and architectural style within the Westmead HCA, HS146, and supports the HCA as a contributory item.</p> <p><b>Meets the level of individual heritage listing.</b></p>

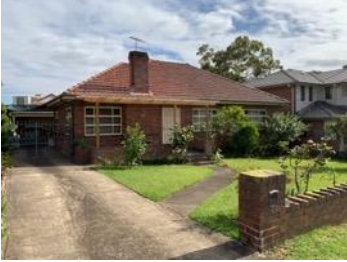
<p>HS146_Austral_45(2)</p>

<p>HS146_Austral_18</p>
HS91	Austral Avenue Housing Commission Housing Group	45-51 Austral Avenue	Local	<p>Heritage Inventory Sheet has detailed historical information and description of physical condition. The assessment of significance is thorough.</p> <p>No. 45-51 are a highly significant group of residences constructed for the purpose of social housing.</p> <p>Condition: Good</p> <p>Integrity: Moderate</p>	<p>The group of residences support and contributes to the Westmead HCA HS146, although are not distinguishable or set apart from other housing commission residence within the local area in architectural style or detailing. It is the opinion of the author that <b>this group of residence should not be individual listed.</b> The group' form and style are simplistic in character and detailing similar to other items within the HCA.</p>

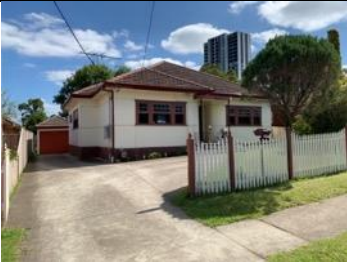
<p data-bbox="1720 1139 1787 1171">HS92</p>

<p data-bbox="1720 810 1928 842">HS146_Austral_51</p>
HS92	Post-war Austerity Style House	33 Grand Avenue	Local	<p data-bbox="902 858 1290 1018">Heritage Inventory Sheet has detailed historical information and description of physical condition. The assessment of significance is thorough.</p> <p data-bbox="902 1058 1290 1185">The Post-War cottage is fibro clad, with timber double hung windows and convex glass panes to the upper sashes.</p> <p data-bbox="902 1225 1093 1257">Condition: Good</p> <p data-bbox="902 1297 1122 1329">Integrity: Moderate</p>	<p data-bbox="1335 858 1682 1050">The 1950 fibro cottage built in the Modernism Austerity style is a poor representation of the style and <b>should not be considered as an individual heritage listed item.</b></p>

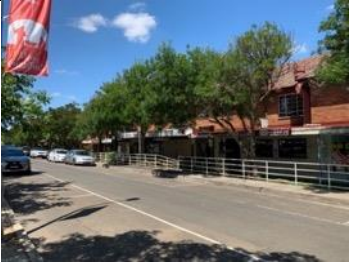
<p>HS96(3)</p>

Item	Name	Address	Listing	Comments	Recommendations	Photographic Evidence
HS96	The Oakes Centre	74 Hawkesbury Road	Local	<p>Heritage Inventory Sheet has detailed historical information and description of physical condition. The assessment of significance is thorough.</p> <p>The group of commercial building, purposely built to support the housing commission residence in the vicinity is unique and could be considered rare in context, to support the establishment of social housing.</p> <p>Condition: Good</p> <p>Integrity: Moderate</p>	<p>A comparative analysis should be undertaken to establish the rarity of the group and the relative significance of its components.</p> <p>The group of commercial buildings <b>supports individual heritage listing</b> as acknowledge and agreed to by the Criteria Assessment by Extent HA.</p>

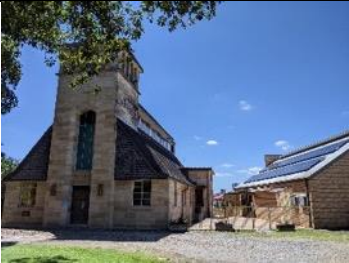
<p>HS96(8)</p>
HS97	St Barnabas Anglican Church	75 Hawkesbury Road	Local	<p>Heritage Inventory Sheet has detailed historical information and description of physical condition. The assessment of significance is thorough.</p> <p>Condition: Fair</p> <p>Integrity: Moderate</p>	<p>The Church and relocated Soldiers Hut <b>meet the criteria for individual heritage listing.</b></p>

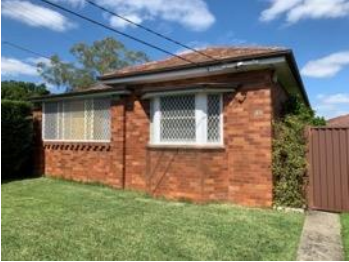
<p>HS99_152(1)</p>

Item	Name	Address	Listing	Comments	Recommendations	Photographic Evidence
HS99	Group of Post-war Bungalows	152-156 Hawkesbury Road	Local	<p>Heritage Inventory Sheet has detailed historical information and description of physical condition. The assessment of significance is thorough.</p> <p>The similar architectural style and detailing of the residence can be found within the Westmead HCA and architectural elements do not set apart the residences from other social housing found in the immediate vicinity.</p> <p>152 Hawkesbury Rd Condition: Fair Integrity: Moderate</p> <p>154 &amp; 156 Hawkesbury Rd Condition: Poor Integrity: Moderate</p>	<p>The group of three residential buildings are not considered worthy to be individually listed heritage items.</p> <p><b>The group should not be considered as an individual heritage listed item.</b></p>

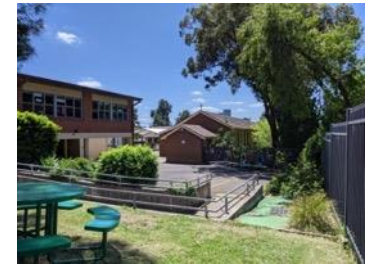
HS101-4

HS100-2
HS101	Sacred Heart Primary School and Church	14 Ralph Street	Local	The dwelling at 14 Ralph Street is used by the Sacred Heart Church as the Parish Office. The school and church buildings are located at the neighbouring address of 12 Ralph Street.  The buildings located onsite are typical of school house building built after the 1950s, found throughout Western Sydney. The built fabric gives an understanding of development of the locality of Westmead but not specially or only in relation to, the construction of the Westmead Housing Commission Estate.  Condition: Good  Integrity: Moderate	The group of buildings noted as Sacred Heart Primary School and Church are not worthy to be listed as an individual heritage item despite their display of the development of Westmead after the Westmead Housing Commission Estate. <b>The group of buildings should not be considered as an individual heritage listed item.</b>

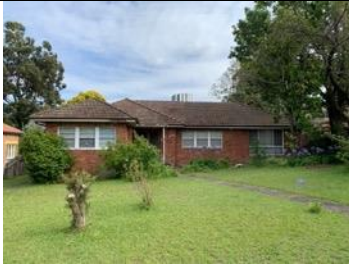
HS146_Austral_13

Number	Street	Contributory	Non-Contributory	Condition	Integrity	Comments	Photograph and reference number
13	Austral Avenue	<input checked="" type="checkbox"/>	<input type="checkbox"/>	<input type="checkbox"/> Poor <input checked="" type="checkbox"/> Fair <input type="checkbox"/> Good	<input type="checkbox"/> Low <input checked="" type="checkbox"/> Moderate <input type="checkbox"/> High	Red brick dwelling consistent with scale and form of HCA, with terracotta roof and original timber windows. This item contributes to the conservation area. Extent HA supporting map dated 10 <sup>th</sup> Nov 2020 indicates this property highlighted as green, Potential Heritage item. No data sheet provided to support the listing.

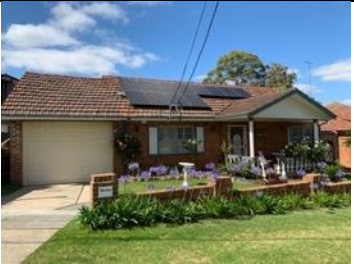
Number	Street	Contributory	Non-Contributory	Condition	Integrity	Comments	Photograph and reference number
14	Austral Avenue	<input type="checkbox"/>	<input checked="" type="checkbox"/>	<input type="checkbox"/> Poor <input checked="" type="checkbox"/> Fair <input type="checkbox"/> Good	<input checked="" type="checkbox"/> Low <input type="checkbox"/> Moderate <input type="checkbox"/> High	Meets the Heritage Contributory level within the HCA.  <b>Noted as contributory in the HCA Study.</b> Heavily modified period cottage with new gable entry portico, new aluminium windows, new entry door and new garage entry. <b>Integrity is severely altered; it does not meet the Heritage Contributory level within the HCA.</b>

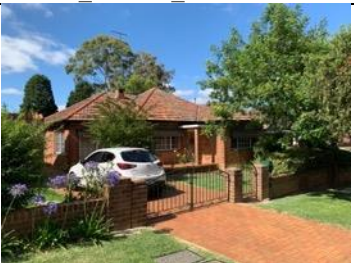
HS146_Austral_16

16	Austral Avenue	<input checked="" type="checkbox"/>	<input type="checkbox"/>	<input type="checkbox"/> Poor <input type="checkbox"/> Fair <input checked="" type="checkbox"/> Good	<input type="checkbox"/> Low <input checked="" type="checkbox"/> Moderate <input type="checkbox"/> High	Terracotta roof covering, red brick cottage consistent with form and scale of HCA. <b>Meets the Heritage Contributory level within the HCA.</b>

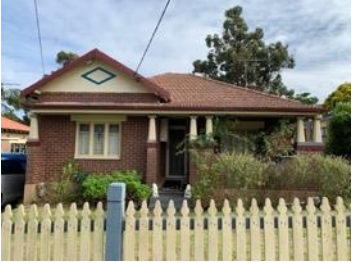
Number	Street	Contributory	Non-Contributory	Condition	Integrity	Comments	Photograph and reference number
17	Austral Avenue	<input checked="" type="checkbox"/>	<input type="checkbox"/>	<input type="checkbox"/> Poor <input type="checkbox"/> Fair <input checked="" type="checkbox"/> Good	<input type="checkbox"/> Low <input type="checkbox"/> Moderate <input checked="" type="checkbox"/> High	Terracotta roof covering, brick Interwar Bungalow, with covered entry. <b>Heritage Listed. Contributes to the HCA.</b>

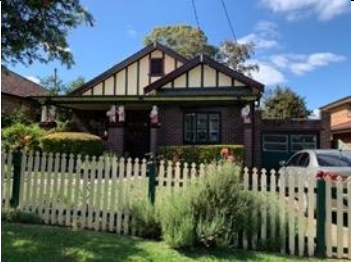
HS146 Austral 18

HS146 Austral 17
18	Austral Avenue	<input checked="" type="checkbox"/>	<input type="checkbox"/>	<input type="checkbox"/> Poor <input type="checkbox"/> Fair <input checked="" type="checkbox"/> Good	<input type="checkbox"/> Low <input type="checkbox"/> Moderate <input checked="" type="checkbox"/> High	Terracotta roof covering, brick Interwar Bungalow, with covered entry. <b>Meets the threshold for individual heritage listing. Contributes to the HCA.</b>

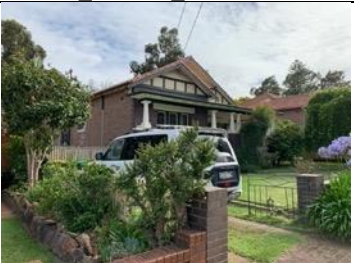
19	Austral Avenue	<input checked="" type="checkbox"/>	<input type="checkbox"/>	<input type="checkbox"/> Poor <input type="checkbox"/> Fair <input checked="" type="checkbox"/> Good	<input type="checkbox"/> Low <input type="checkbox"/> Moderate <input checked="" type="checkbox"/> High	Terracotta roof covering, brick Interwar Bungalow, with covered entry. <b>Heritage Listed. Contributes to the HCA.</b>

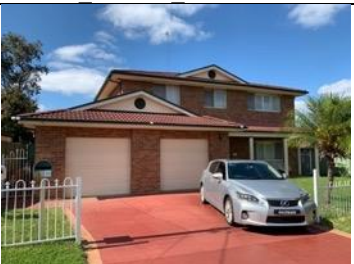
HS146 Austral 20

HS146 Austral 19
20	Austral Avenue	<input type="checkbox"/>	<input checked="" type="checkbox"/>	<input type="checkbox"/> Poor <input type="checkbox"/> Fair <input type="checkbox"/> Good	<input type="checkbox"/> Low <input type="checkbox"/> Moderate <input type="checkbox"/> High	Large, two storey dwelling from 21 <sup>st</sup> century. Form and scale not consistent with the HCA. <b>This item does not meet the threshold for contributory item.</b>

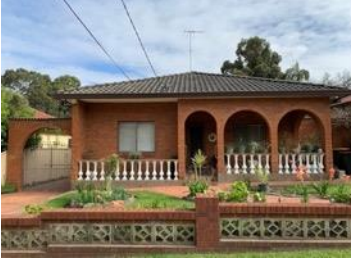
Number	Street	Contributory	Non-Contributory	Condition	Integrity	Comments	Photograph and reference number
21	Austral Avenue	<input type="checkbox"/>	<input checked="" type="checkbox"/>	<input type="checkbox"/> Poor <input checked="" type="checkbox"/> Fair <input type="checkbox"/> Good	<input checked="" type="checkbox"/> Low <input type="checkbox"/> Moderate <input type="checkbox"/> High	Heavily modified period cottage. New hip roof form, new aluminium windows, new entry portico. Integrity severely altered, <b>does not meet the Heritage Contributory level within the HCA.</b>

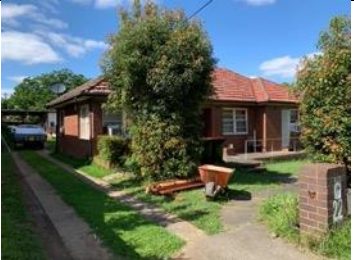
HS146 Austral 22

HS146 Austral 21
22	Austral Avenue	<input checked="" type="checkbox"/>	<input type="checkbox"/>	<input checked="" type="checkbox"/> Poor <input type="checkbox"/> Fair <input type="checkbox"/> Good	<input type="checkbox"/> Low <input checked="" type="checkbox"/> Moderate <input type="checkbox"/> High	Terracotta roof covering, red brick cottage consistent with form and scale of HCA. Despite the poor condition, there is still a moderate degree of integrity. Works are required to rectify deterioration although original material remains. <b>Meets the Heritage Contributory level within the HCA.</b>

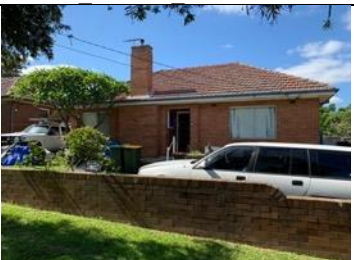
HS146 Austral 24

HS146 Austral 23
24	Austral Avenue	<input checked="" type="checkbox"/>	<input type="checkbox"/>	<input type="checkbox"/> Poor <input checked="" type="checkbox"/> Fair <input type="checkbox"/> Good	<input type="checkbox"/> Low <input checked="" type="checkbox"/> Moderate <input type="checkbox"/> High	Terracotta roof covering, red brick cottage consistent with form and scale of HCA. <b>Meets the Heritage Contributory level within the HCA.</b>

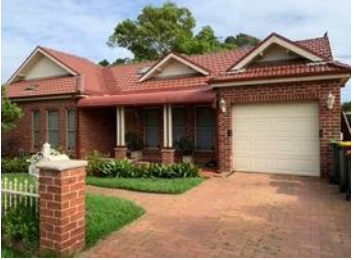
Number	Street	Contributory	Non-Contributory	Condition	Integrity	Comments	Photograph and reference number
25	Austral Avenue	<input type="checkbox"/>	<input checked="" type="checkbox"/>	N/A	N/A	Single storey dwelling from 21 <sup>st</sup> century. Form and scale consistent with the HCA. <b>This item does not meet the threshold for contributory.</b>

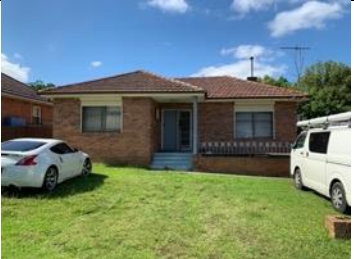
<p>HS146_Austral_26</p>

<p>HS146 Austral 25</p>
26	Austral Avenue	<input checked="" type="checkbox"/>	<input type="checkbox"/>	<input type="checkbox"/> Poor <input checked="" type="checkbox"/> Fair <input type="checkbox"/> Good	<input checked="" type="checkbox"/> Low <input type="checkbox"/> Moderate <input type="checkbox"/> High	<p>Terracotta roof covering, red brick cottage consistent with form and scale of HCA. <b>Meets the Heritage Contributory level within the HCA.</b></p> <p>We agree with the initial assessment in the heritage inventory sheet and contribution map as completed by Extent Heritage Advisors. Refer to the heritage inventory sheet for further details.</p>

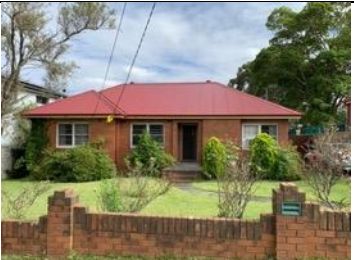
<p>HS146 Austral 27</p>

27	Austral Avenue	<input checked="" type="checkbox"/>	<input type="checkbox"/>	<input type="checkbox"/> Poor <input checked="" type="checkbox"/> Fair <input type="checkbox"/> Good	<input type="checkbox"/> Low <input checked="" type="checkbox"/> Moderate <input type="checkbox"/> High	<p>Painted metal roof covering, red brick cottage consistent with form and scale of HCA. <b>Meets the Heritage Contributory level within the HCA.</b></p>

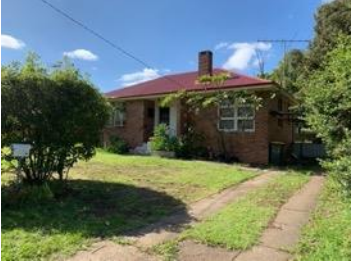
Number	Street	Contributory	Non-Contributory	Condition	Integrity	Comments	Photograph and reference number
28	Austral Avenue	<input checked="" type="checkbox"/>	<input type="checkbox"/>	<input type="checkbox"/> Poor <input checked="" type="checkbox"/> Fair <input type="checkbox"/> Good	<input type="checkbox"/> Low <input checked="" type="checkbox"/> Moderate <input type="checkbox"/> High	Terracotta roof covering, red brick cottage consistent with form and scale of HCA. <b>Meets the Heritage Contributory level within the HCA.</b>

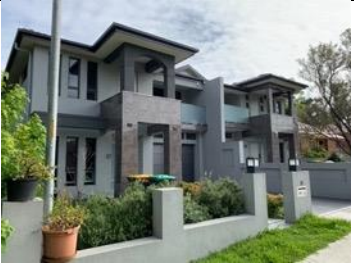
HS146 Austral 28
29	Austral Avenue	<input type="checkbox"/>	<input checked="" type="checkbox"/>	N/A	N/A	Large, two storey duplex-dwellings from 21 <sup>st</sup> century. Form and scale not consistent with the HCA. <b>This item does not meet the threshold for contributory.</b>

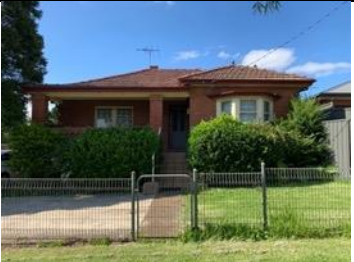
HS146 Austral 30

HS146 Austral 29
30	Austral Avenue	<input checked="" type="checkbox"/>	<input type="checkbox"/>	<input type="checkbox"/> Poor <input type="checkbox"/> Fair <input checked="" type="checkbox"/> Good	<input type="checkbox"/> Low <input checked="" type="checkbox"/> Moderate <input type="checkbox"/> High	Terracotta roof covering, red brick cottage consistent with form and scale of HCA. <b>Meets the Heritage Contributory level within the HCA.</b>

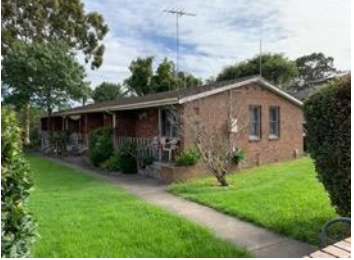
Number	Street	Contributory	Non-Contributory	Condition	Integrity	Comments	Photograph and reference number
31A	Austral Avenue	<input checked="" type="checkbox"/>	<input type="checkbox"/>	<input type="checkbox"/> Poor <input checked="" type="checkbox"/> Fair <input type="checkbox"/> Good	<input type="checkbox"/> Low <input checked="" type="checkbox"/> Moderate <input type="checkbox"/> High	Multi-unit flat building single storey. Simplistic in form and detailing. Consideration needs to be given to group listing with 27&28 Moree Ave, 41a and 42 Grand Avenue, which provides direct pedestrian access from Alexandria Avenue transportation hub. <b>This item contributes to the conservation area.</b>

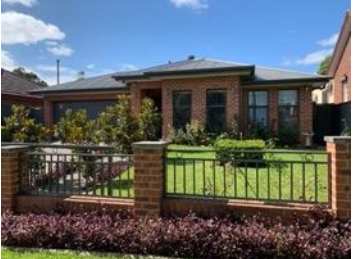
HS146 Austral 32

HS146_Austral_31A
32	Austral Avenue	<input type="checkbox"/>	<input checked="" type="checkbox"/>	N/A	N/A	Single storey dwelling from 21 <sup>st</sup> century. The scale is consistent with the HCA although form and era of construction differs from the contributory items in the HCA. This item does not meet the threshold for contributory.

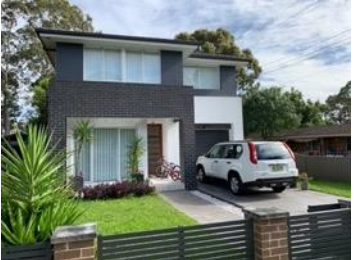
HS146 Austral 33

33	Austral Avenue	<input type="checkbox"/>	<input checked="" type="checkbox"/>	N/A	N/A	Large, two storey dwelling from 21 <sup>st</sup> century. Form and scale not consistent with the HCA. <b>This item does not meet the threshold for contributory.</b>

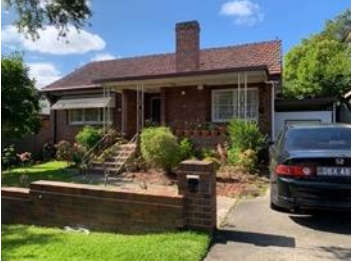
Number	Street	Contributory	Non-Contributory	Condition	Integrity	Comments	Photograph and reference number
34	Austral Avenue	<input checked="" type="checkbox"/>	<input type="checkbox"/>	<input type="checkbox"/> Poor <input checked="" type="checkbox"/> Fair <input type="checkbox"/> Good	<input type="checkbox"/> Low <input checked="" type="checkbox"/> Moderate <input type="checkbox"/> High	Terracotta roof covering, red brick cottage consistent with form and scale of HCA. <b>Meets the Heritage Contributory level within the HCA.</b>

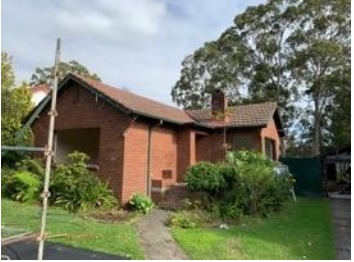
HS146 Austral 35

HS146 Austral 34
35	Austral Avenue	<input checked="" type="checkbox"/>	<input type="checkbox"/>	<input type="checkbox"/> Poor <input checked="" type="checkbox"/> Fair <input type="checkbox"/> Good	<input type="checkbox"/> Low <input checked="" type="checkbox"/> Moderate <input type="checkbox"/> High	Terracotta roof covering, red brick cottage consistent with form and scale of HCA. Currently undergoing alterations and additions including removal of door and timber windows. <b>Meets the Heritage Contributory level within the HCA.</b>

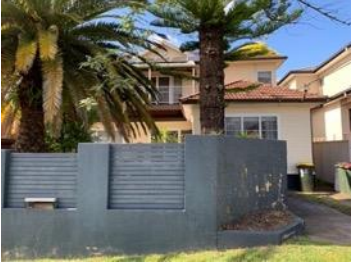
36	Austral Avenue	<input type="checkbox"/>	<input checked="" type="checkbox"/>	N/A	N/A	<b>Noted as contributory in the HCA Study.</b> Large, two storey dwelling from 21 <sup>st</sup> century. Form and scale not consistent with the HCA. <b>This item does not meet the threshold for contributory.</b>

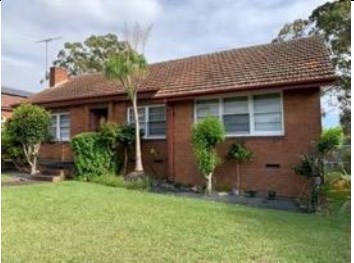
HS146 Austral 37

HS146 Austral 36
37	Austral Avenue	<input checked="" type="checkbox"/>	<input type="checkbox"/>	<input type="checkbox"/> Poor <input checked="" type="checkbox"/> Fair <input type="checkbox"/> Good	<input type="checkbox"/> Low <input checked="" type="checkbox"/> Moderate <input type="checkbox"/> High	Terracotta roof covering, red brick cottage consistent with form and scale of HCA. <b>Meets the Heritage Contributory level within the HCA.</b>

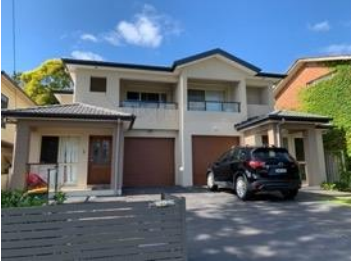
Number	Street	Contributory	Non-Contributory	Condition	Integrity	Comments	Photograph and reference number
38	Austral Avenue	<input type="checkbox"/>	<input checked="" type="checkbox"/>	N/A	N/A	Large, two storey dwelling from 21 <sup>st</sup> century. Form and scale not consistent with the HCA. <b>This item does not meet the threshold for contributory.</b>

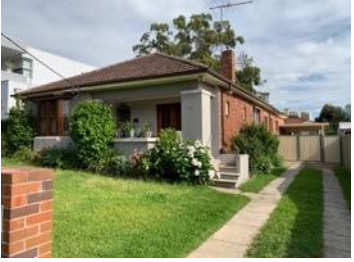
HS146 Austral 38
39	Austral Avenue	<input checked="" type="checkbox"/>	<input type="checkbox"/>	<input type="checkbox"/> Poor <input checked="" type="checkbox"/> Fair <input type="checkbox"/> Good	<input type="checkbox"/> Low <input checked="" type="checkbox"/> Moderate <input type="checkbox"/> High	Terracotta roof covering, red brick cottage consistent with form and scale of HCA. <b>Meets the Heritage Contributory level within the HCA.</b>

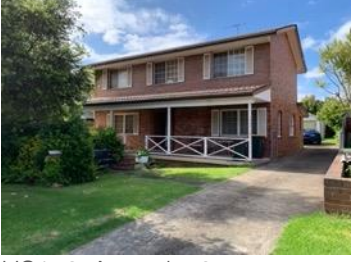
HS146 Austral 40

HS146 Austral 39
40	Austral Avenue	<input type="checkbox"/>	<input checked="" type="checkbox"/>	<input type="checkbox"/> Poor <input checked="" type="checkbox"/> Fair <input type="checkbox"/> Good	<input checked="" type="checkbox"/> Low <input type="checkbox"/> Moderate <input type="checkbox"/> High	Heavily modified period cottage. New second storey. Integrity severely altered, <b>does not meet the Heritage Contributory level within the HCA.</b>

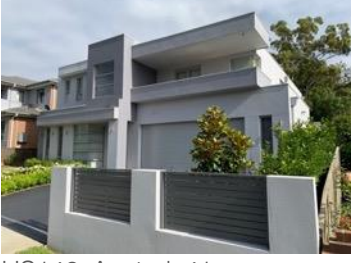
HS146 Austral 41

41	Austral Avenue	<input type="checkbox"/>	<input checked="" type="checkbox"/>	N/A	N/A	Large, two storey dwelling from 21 <sup>st</sup> century. Form and scale not consistent with the HCA. <b>This item does not meet the threshold for contributory.</b>

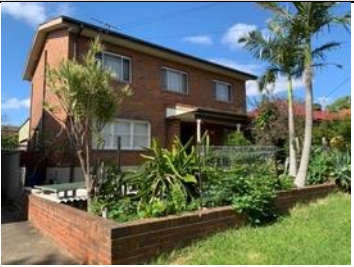
Number	Street	Contributory	Non-Contributory	Condition	Integrity	Comments	Photograph and reference number
42	Austral Avenue	<input type="checkbox"/>	<input checked="" type="checkbox"/>	<input type="checkbox"/> Poor <input checked="" type="checkbox"/> Fair <input type="checkbox"/> Good	<input checked="" type="checkbox"/> Low <input type="checkbox"/> Moderate <input type="checkbox"/> High	<b>Noted as contributory in the HCA Study.</b> Heavily modified period cottage. New second storey. Integrity severely altered, <b>does not meet the Heritage Contributory level within the HCA.</b>

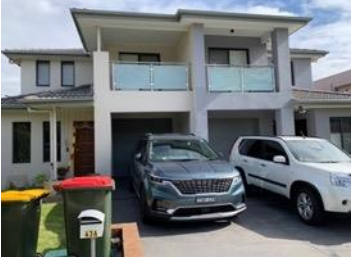
HS146 Austral 42
43	Austral Avenue	<input type="checkbox"/>	<input checked="" type="checkbox"/>	N/A	N/A	Large, two storey duplex-dwelling from 21 <sup>st</sup> century. Form and scale not consistent with the HCA. <b>This item does not meet the threshold for contributory.</b>

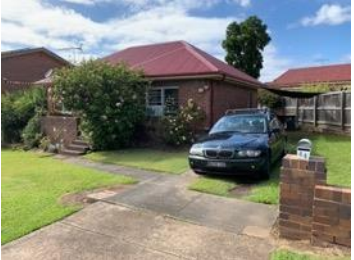
HS146 Austral 44

HS146 Austral 43
44	Austral Avenue	<input checked="" type="checkbox"/>	<input type="checkbox"/>	<input type="checkbox"/> Poor <input type="checkbox"/> Fair <input checked="" type="checkbox"/> Good	<input type="checkbox"/> Low <input type="checkbox"/> Moderate <input checked="" type="checkbox"/> High	Red terracotta roof covering, red brick cottage consistent with form and scale of HCA. <b>Meets the Heritage Contributory level within the HCA.</b>

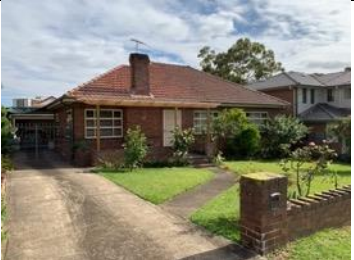
HS146 Austral 45

45	Austral Avenue	<input checked="" type="checkbox"/>	<input type="checkbox"/>	<input type="checkbox"/> Poor <input type="checkbox"/> Fair <input checked="" type="checkbox"/> Good	<input type="checkbox"/> Low <input checked="" type="checkbox"/> Moderate <input type="checkbox"/> High	Terracotta roof covering, red brick cottage consistent with form and scale of HCA. <b>Meets the Heritage Contributory level within the HCA.</b>

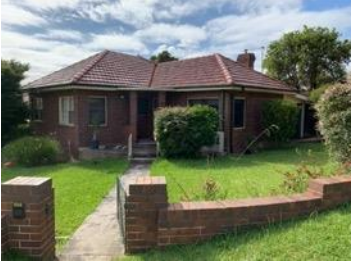
Number	Street	Contributory	Non-Contributory	Condition	Integrity	Comments	Photograph and reference number
46	Austral Avenue	<input checked="" type="checkbox"/>	<input type="checkbox"/>	<input type="checkbox"/> Poor <input type="checkbox"/> Fair <input checked="" type="checkbox"/> Good	<input type="checkbox"/> Low <input type="checkbox"/> Moderate <input checked="" type="checkbox"/> High	Corner block residence with low-lying matching brick fence. Suitable garden planting. Terracotta roof covering, red brick cottage consistent with form and scale of HCA. <b>Meets the Heritage Contributory level within the HCA.</b>

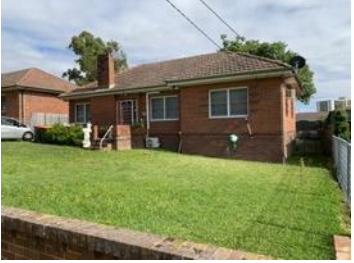
HS146 Austral 47

HS146 Austral 46
47	Austral Avenue	<input checked="" type="checkbox"/>	<input type="checkbox"/>	<input type="checkbox"/> Poor <input type="checkbox"/> Fair <input checked="" type="checkbox"/> Good	<input type="checkbox"/> Low <input checked="" type="checkbox"/> Moderate <input type="checkbox"/> High	Terracotta roof covering, red brick cottage consistent with form and scale of HCA. <b>Meets the Heritage Contributory level within the HCA.</b>

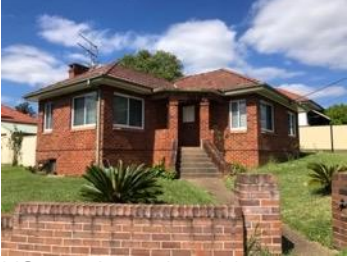
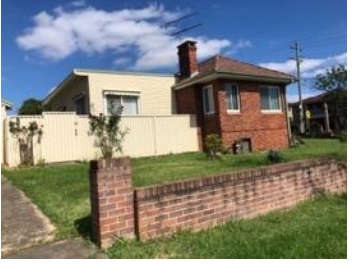
HS146 Austral 48(1)

48	Austral Avenue	<input checked="" type="checkbox"/>	<input type="checkbox"/>	<input type="checkbox"/> Poor <input type="checkbox"/> Fair <input checked="" type="checkbox"/> Good	<input type="checkbox"/> Low <input checked="" type="checkbox"/> Moderate <input type="checkbox"/> High	Dwelling is in a prominent corner block location. It includes an addition to the south (Toohey Street side) but otherwise retains original form and scale. Timber windows have been replaced with aluminium. <b>This item contributes to the conservation area.</b>

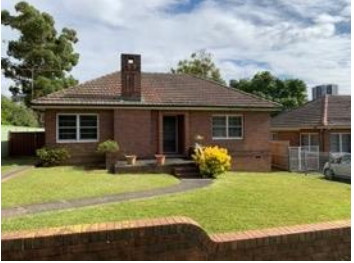
Number	Street	Contributory	Non-Contributory	Condition	Integrity	Comments	Photograph and reference number
49	Austral Avenue	<input checked="" type="checkbox"/>	<input type="checkbox"/>	<input type="checkbox"/> Poor <input type="checkbox"/> Fair <input checked="" type="checkbox"/> Good	<input type="checkbox"/> Low <input checked="" type="checkbox"/> Moderate <input type="checkbox"/> High	Terracotta roof covering, red brick cottage consistent with form and scale of HCA. <b>Meets the Heritage Contributory level within the HCA.</b>

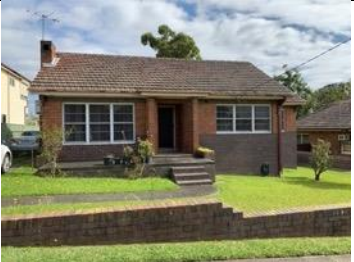
HS146 Austral 51

HS146 Austral 49
51	Austral Avenue	<input checked="" type="checkbox"/>	<input type="checkbox"/>	<input type="checkbox"/> Poor <input type="checkbox"/> Fair <input checked="" type="checkbox"/> Good	<input type="checkbox"/> Low <input checked="" type="checkbox"/> Moderate <input type="checkbox"/> High	Terracotta roof covering, red brick cottage consistent with form and scale of HCA. <b>Meets the Heritage Contributory level within the HCA.</b>

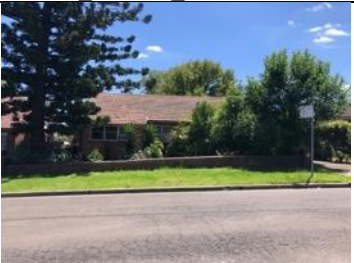
1	Church Avenue	<input checked="" type="checkbox"/>	<input type="checkbox"/>	<input type="checkbox"/> Poor <input type="checkbox"/> Fair <input checked="" type="checkbox"/> Good	<input type="checkbox"/> Low <input type="checkbox"/> Moderate <input checked="" type="checkbox"/> High	Red brick dwelling consistent with scale and form of HCA, with terracotta roof and original timber windows. <b>This item contributes to the conservation area.</b>

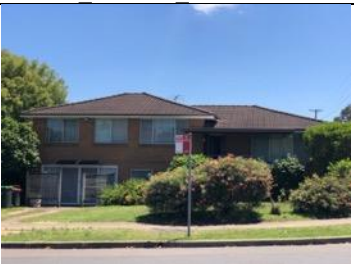
HS146 Church 1A

HS146 Church 1
1A	Church Avenue	<input type="checkbox"/>	<input checked="" type="checkbox"/>	N/A	N/A	Two storey dwelling of ca. late 20th Century construction. Blonde brick with terracotta roof and aluminium windows, scale and form that is not consistent with the HCA. <b>This item does not contribute to the conservation area.</b> Given the location of the property on the HCA

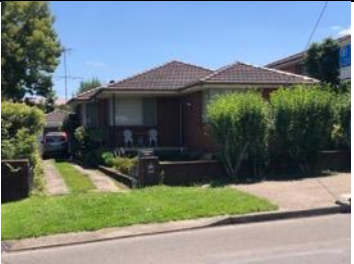
Number	Street	Contributory	Non-Contributory	Condition	Integrity	Comments	Photograph and reference number
1B	Church Avenue	<input checked="" type="checkbox"/>	<input type="checkbox"/>	<input type="checkbox"/> Poor <input type="checkbox"/> Fair <input checked="" type="checkbox"/> Good	<input type="checkbox"/> Low <input checked="" type="checkbox"/> Moderate <input type="checkbox"/> High	boundary, it is possible to consider it for removal from the HCA. Red brick dwelling consistent with scale and form of HCA, with terracotta roof and aluminium windows replacing the original timber windows. <b>This item contributes to the conservation area.</b>

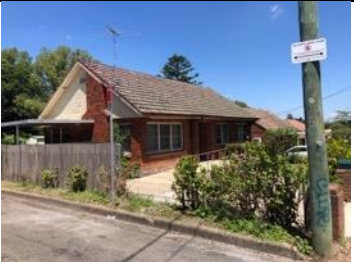
HS146 Church 2

HS146 Church 1B
2	Church Avenue	<input checked="" type="checkbox"/>	<input type="checkbox"/>	<input type="checkbox"/> Poor <input checked="" type="checkbox"/> Fair <input type="checkbox"/> Good	<input type="checkbox"/> Low <input checked="" type="checkbox"/> Moderate <input type="checkbox"/> High	Red brick dwelling consistent with scale and form of HCA, with terracotta roof and original timber windows. A ramp with railings has been added to access the front door. <b>This item contributes to the conservation area.</b>

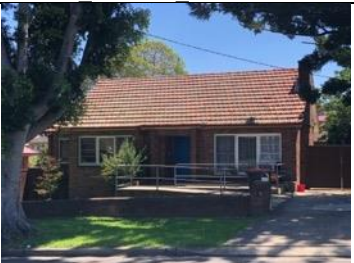
HS146 Church 3

3	Church Avenue	<input checked="" type="checkbox"/>	<input type="checkbox"/>	<input type="checkbox"/> Poor <input type="checkbox"/> Fair <input checked="" type="checkbox"/> Good	<input type="checkbox"/> Low <input checked="" type="checkbox"/> Moderate <input type="checkbox"/> High	Red brick dwelling consistent with scale and form of HCA, with terracotta roof and original timber windows. <b>This item contributes to the conservation area.</b>

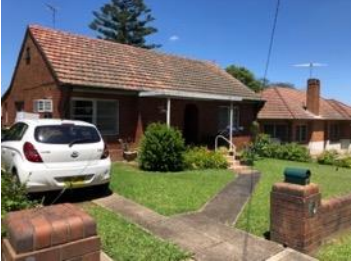
Number	Street	Contributory	Non-Contributory	Condition	Integrity	Comments	Photograph and reference number
4	Church Avenue	<input checked="" type="checkbox"/>	<input type="checkbox"/>	<input type="checkbox"/> Poor <input type="checkbox"/> Fair <input checked="" type="checkbox"/> Good	<input type="checkbox"/> Low <input checked="" type="checkbox"/> Moderate <input type="checkbox"/> High	Red brick dwelling consistent with scale and form of HCA, with terracotta roof and original timber windows. <b>This item contributes to the conservation area.</b>

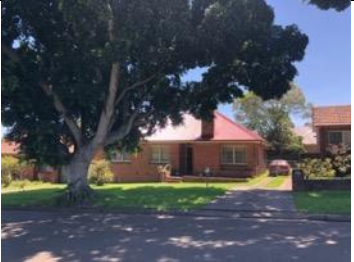
HS146 Church 5

HS146 Church 4
5	Church Avenue	<input checked="" type="checkbox"/>	<input type="checkbox"/>	<input type="checkbox"/> Poor <input type="checkbox"/> Fair <input checked="" type="checkbox"/> Good	<input type="checkbox"/> Low <input checked="" type="checkbox"/> Moderate <input type="checkbox"/> High	Red brick dwelling consistent with scale and form of HCA, with original timber windows. Metal sheeting to the roof likely replaces earlier terracotta roof. <b>This item contributes to the conservation area.</b>

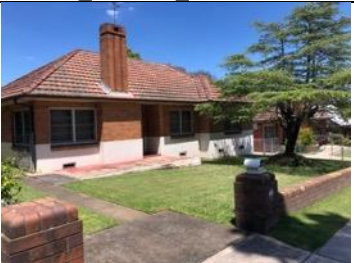
6	Church Avenue	<input checked="" type="checkbox"/>	<input type="checkbox"/>	<input type="checkbox"/> Poor <input type="checkbox"/> Fair <input checked="" type="checkbox"/> Good	<input type="checkbox"/> Low <input checked="" type="checkbox"/> Moderate <input type="checkbox"/> High	Red brick dwelling with rendered base, consistent with scale and form of HCA, with terracotta roof and original timber windows. <b>This item contributes to the conservation area.</b>

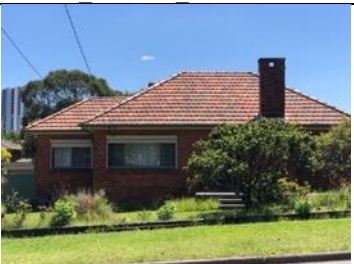
HS146 Church 7

HS146 Church 6
7	Church Avenue	<input checked="" type="checkbox"/>	<input type="checkbox"/>	<input type="checkbox"/> Poor <input type="checkbox"/> Fair <input checked="" type="checkbox"/> Good	<input type="checkbox"/> Low <input checked="" type="checkbox"/> Moderate <input type="checkbox"/> High	Red brick dwelling consistent with scale and form of HCA, with terracotta roof and aluminium windows replacing the original timber windows. <b>This item contributes to the conservation area.</b>

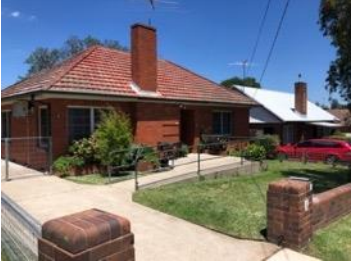
Number	Street	Contributory	Non-Contributory	Condition	Integrity	Comments	Photograph and reference number
8	Church Avenue	<input checked="" type="checkbox"/>	<input type="checkbox"/>	<input type="checkbox"/> Poor <input type="checkbox"/> Fair <input checked="" type="checkbox"/> Good	<input type="checkbox"/> Low <input checked="" type="checkbox"/> Moderate <input type="checkbox"/> High	Red brick dwelling consistent with scale and form of HCA, with terracotta roof and original timber windows. A ramp with railings has been added to access the front door. <b>This item contributes to the conservation area.</b>

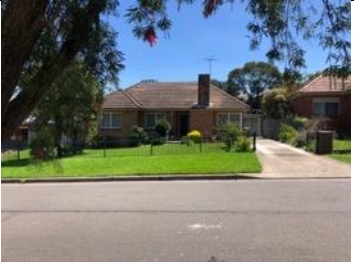
HS146 Church 9

HS146 Church 8
9	Church Avenue	<input checked="" type="checkbox"/>	<input type="checkbox"/>	<input type="checkbox"/> Poor <input type="checkbox"/> Fair <input checked="" type="checkbox"/> Good	<input type="checkbox"/> Low <input type="checkbox"/> Moderate <input checked="" type="checkbox"/> High	Red brick dwelling consistent with scale and form of HCA, with terracotta roof and original timber windows. <b>This item contributes to the conservation area.</b>

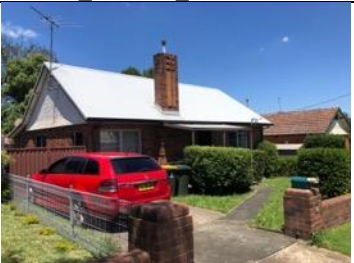
10	Church Avenue	<input checked="" type="checkbox"/>	<input type="checkbox"/>	<input type="checkbox"/> Poor <input type="checkbox"/> Fair <input checked="" type="checkbox"/> Good	<input type="checkbox"/> Low <input checked="" type="checkbox"/> Moderate <input type="checkbox"/> High	Red brick dwelling consistent with scale and form of HCA, with original timber windows. Light coloured metal sheeting to the roof likely replaces earlier terracotta roof. <b>This item contributes to the conservation area.</b>

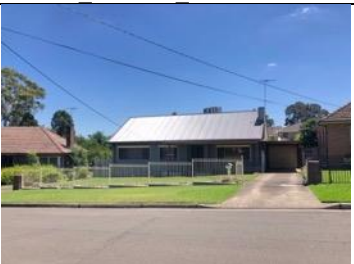
HS146 Church 11

HS146 Church 10
11	Church Avenue	<input type="checkbox"/>	<input checked="" type="checkbox"/>	<input type="checkbox"/> Poor <input checked="" type="checkbox"/> Fair <input type="checkbox"/> Good	<input checked="" type="checkbox"/> Low <input type="checkbox"/> Moderate <input checked="" type="checkbox"/> High	<b>Noted as contributory in HCA study.</b> Dwelling is highly altered, with a metal roof, rendered wall finish and aluminium windows. The scale and form of the earlier design is evident. <b>It does not meet the threshold for contributory.</b>

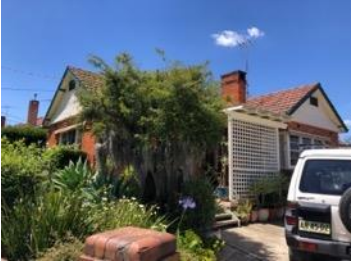
Number	Street	Contributory	Non-Contributory	Condition	Integrity	Comments	Photograph and reference number
12	Church Avenue	<input checked="" type="checkbox"/>	<input type="checkbox"/>	<input type="checkbox"/> Poor <input type="checkbox"/> Fair <input checked="" type="checkbox"/> Good	<input type="checkbox"/> Low <input type="checkbox"/> Moderate <input checked="" type="checkbox"/> High	Red brick dwelling consistent with scale and form of HCA, with terracotta roof and original timber windows. <b>This item contributes to the conservation area.</b>

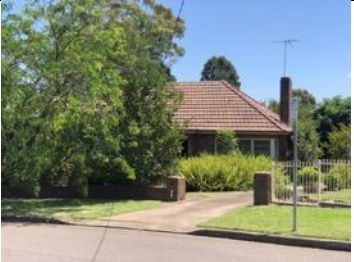
HS146 Church 13

HS146 Church 12
13	Church Avenue	<input checked="" type="checkbox"/>	<input type="checkbox"/>	<input type="checkbox"/> Poor <input type="checkbox"/> Fair <input checked="" type="checkbox"/> Good	<input type="checkbox"/> Low <input type="checkbox"/> Moderate <input checked="" type="checkbox"/> High	Red brick dwelling consistent with scale and form of HCA, with terracotta roof and original timber windows. <b>This item contributes to the conservation area.</b>

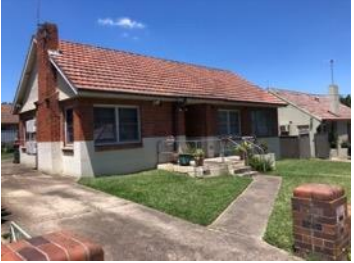
Number	Street	Contributory	Non-Contributory	Condition	Integrity	Comments	Photograph and reference number
16	Church Avenue	<input checked="" type="checkbox"/>	<input type="checkbox"/>	<input type="checkbox"/> Poor <input checked="" type="checkbox"/> Fair <input type="checkbox"/> Good	<input type="checkbox"/> Low <input type="checkbox"/> Moderate <input checked="" type="checkbox"/> High	Red brick dwelling with rendered base, consistent with scale and form of HCA, with terracotta roof and original timber windows. <b>This item contributes to the conservation area.</b>

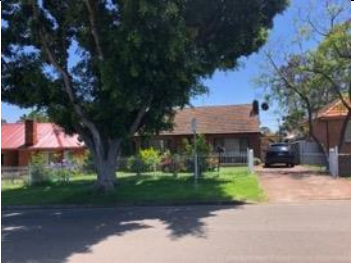
HS146 Church 17

HS146 Church 16
17	Church Avenue	<input checked="" type="checkbox"/>	<input type="checkbox"/>	<input type="checkbox"/> Poor <input type="checkbox"/> Fair <input checked="" type="checkbox"/> Good	<input type="checkbox"/> Low <input checked="" type="checkbox"/> Moderate <input type="checkbox"/> High	Red brick dwelling consistent with scale and form of HCA, with terracotta roof and aluminium windows replacing the original timber windows. <b>This item contributes to the conservation area.</b>

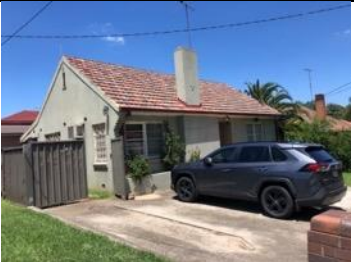
18	Church Avenue	<input checked="" type="checkbox"/>	<input type="checkbox"/>	<input type="checkbox"/> Poor <input checked="" type="checkbox"/> Fair <input type="checkbox"/> Good	<input type="checkbox"/> Low <input checked="" type="checkbox"/> Moderate <input type="checkbox"/> High	Rendered brick dwelling consistent with scale and form of HCA, with terracotta roof and original timber windows. <b>This item contributes to the conservation area.</b>

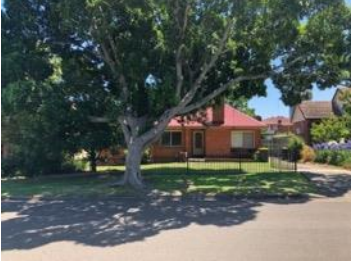
Number	Street	Contributory	Non-Contributory	Condition	Integrity	Comments	Photograph and reference number
19	Church Avenue	<input checked="" type="checkbox"/>	<input type="checkbox"/>	<input type="checkbox"/> Poor <input type="checkbox"/> Fair <input checked="" type="checkbox"/> Good	<input type="checkbox"/> Low <input checked="" type="checkbox"/> Moderate <input type="checkbox"/> High	Dwelling conforms to the dominant scale and design, although has been altered with a metal roof and aluminium windows. <b>This item contributes to the conservation area.</b>

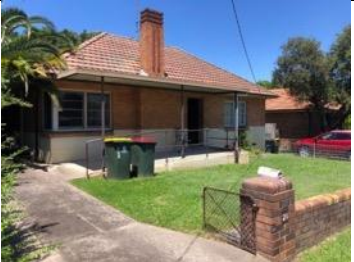
HS146 Church 20

HS146 Church 19
20	Church Avenue	<input checked="" type="checkbox"/>	<input type="checkbox"/>	<input type="checkbox"/> Poor <input type="checkbox"/> Fair <input checked="" type="checkbox"/> Good	<input type="checkbox"/> Low <input checked="" type="checkbox"/> Moderate <input type="checkbox"/> High	Red brick dwelling with rendered base, consistent with scale and form of HCA, with terracotta roof and original timber windows. <b>This item contributes to the conservation area.</b>

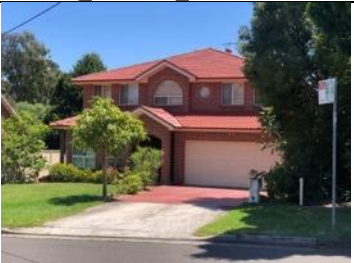
21	Church Avenue	<input type="checkbox"/>	<input checked="" type="checkbox"/>	N/A	N/A	Dwelling is not consistent with the HCA. It is a late 20 <sup>th</sup> /early 21 <sup>st</sup> Century, two storey structure with red bricks and terracotta roof. <b>This item does not meet the threshold for contributory.</b>

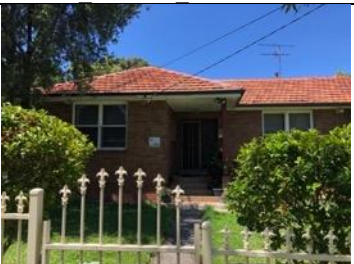
HS146 Church 22

HS146 Church 21
22	Church Avenue	<input checked="" type="checkbox"/>	<input type="checkbox"/>	<input type="checkbox"/> Poor <input type="checkbox"/> Fair <input checked="" type="checkbox"/> Good	<input type="checkbox"/> Low <input type="checkbox"/> Moderate <input checked="" type="checkbox"/> High	Red brick dwelling consistent with scale and form of HCA, with terracotta roof and original timber windows. <b>This item contributes to the conservation area.</b>

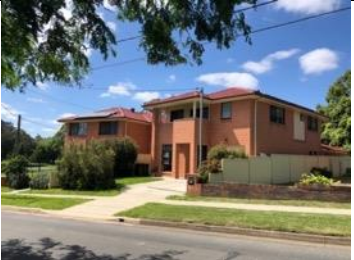
24	Church Avenue	<input type="checkbox"/>	<input checked="" type="checkbox"/>	N/A	N/A	Large, two storey dwelling from 21 <sup>st</sup> century. Form and scale not consistent with the HCA. <b>This item does not meet the threshold for contributory.</b>

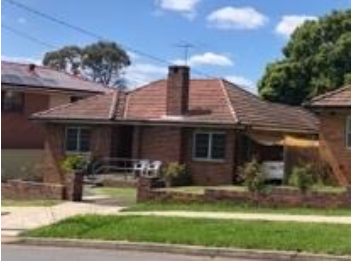
Number	Street	Contributory	Non-Contributory	Condition	Integrity	Comments	Photograph and reference number
26	Church Avenue	<input checked="" type="checkbox"/>	<input type="checkbox"/>	<input type="checkbox"/> Poor <input type="checkbox"/> Fair <input checked="" type="checkbox"/> Good	<input type="checkbox"/> Low <input checked="" type="checkbox"/> Moderate <input type="checkbox"/> High	Red brick dwelling consistent with scale and form of HCA, with terracotta roof and original timber windows. <b>This item contributes to the conservation area.</b>

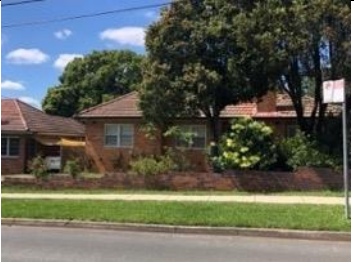
HS146 Church 28

HS146 Church 26
28	Church Avenue	<input checked="" type="checkbox"/>	<input type="checkbox"/>	<input type="checkbox"/> Poor <input type="checkbox"/> Fair <input checked="" type="checkbox"/> Good	<input type="checkbox"/> Low <input type="checkbox"/> Moderate <input checked="" type="checkbox"/> High	Blonde brick dwelling consistent with scale and form of HCA, with terracotta roof and original timber windows. <b>This item contributes to the conservation area.</b>

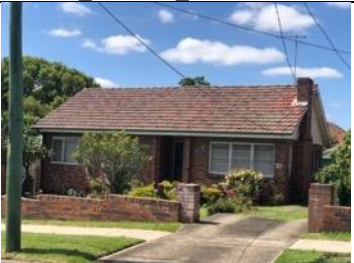
30	Church Avenue	<input checked="" type="checkbox"/>	<input type="checkbox"/>	<input type="checkbox"/> Poor <input type="checkbox"/> Fair <input checked="" type="checkbox"/> Good	<input type="checkbox"/> Low <input type="checkbox"/> Moderate <input checked="" type="checkbox"/> High	Red brick dwelling consistent with scale and form of HCA, with terracotta roof and original timber windows. <b>This item contributes to the conservation area.</b>

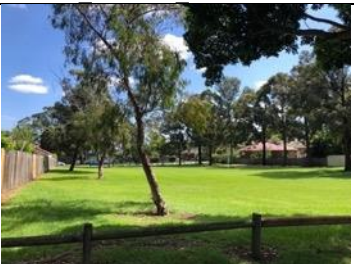
HS146 Church 31

HS146 Church 30
31	Church Avenue	<input checked="" type="checkbox"/>	<input type="checkbox"/>	<input type="checkbox"/> Poor <input type="checkbox"/> Fair <input checked="" type="checkbox"/> Good	<input type="checkbox"/> Low <input checked="" type="checkbox"/> Moderate <input type="checkbox"/> High	Austral Avenue Reserve is contributory to the garden city setting. <b>This item contributes to the conservation area.</b>

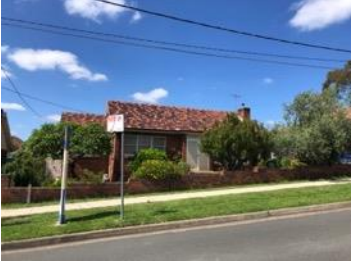
Number	Street	Contributory	Non-Contributory	Condition	Integrity	Comments	Photograph and reference number
32	Church Avenue	<input checked="" type="checkbox"/>	<input type="checkbox"/>	<input type="checkbox"/> Poor <input type="checkbox"/> Fair <input checked="" type="checkbox"/> Good	<input type="checkbox"/> Low <input type="checkbox"/> Moderate <input checked="" type="checkbox"/> High	Red brick dwelling consistent with scale and form of HCA, with terracotta roof and original timber windows. <b>This item contributes to the conservation area.</b>

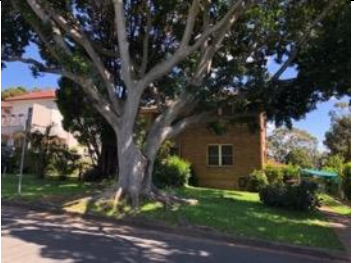
HS146_Church_33

HS146 Church 32
33	Church Avenue	<input type="checkbox"/>	<input checked="" type="checkbox"/>	<input type="checkbox"/> Poor <input type="checkbox"/> Fair <input checked="" type="checkbox"/> Good	<input checked="" type="checkbox"/> Low <input type="checkbox"/> Moderate <input type="checkbox"/> High	<b>Noted as contributory in HCA study.</b> Large, two storey dwellings within the proposed HCA, possibly of a later era of construction. Simple form with timber double hung windows. An addition has been constructed to the north to include an additional living space on the upper level above a covered portico. <b>This item does not meet the threshold of contributory.</b>

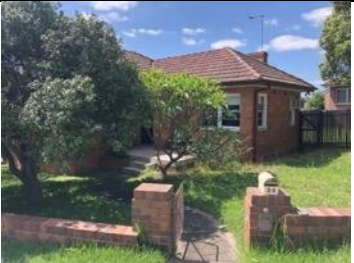
HS146 Church 34

34	Church Avenue	<input checked="" type="checkbox"/>	<input type="checkbox"/>	<input type="checkbox"/> Poor <input type="checkbox"/> Fair <input checked="" type="checkbox"/> Good	<input type="checkbox"/> Low <input type="checkbox"/> Moderate <input checked="" type="checkbox"/> High	Red brick dwelling consistent with scale and form of HCA, with terracotta roof and original timber windows. <b>This item contributes to the conservation area.</b>

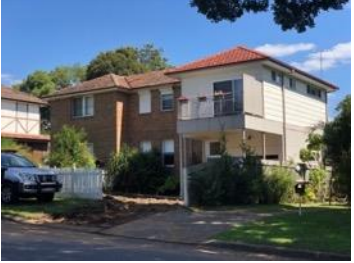
Number	Street	Contributory	Non-Contributory	Condition	Integrity	Comments	Photograph and reference number
35	Church Avenue	<input type="checkbox"/>	<input checked="" type="checkbox"/>	N/A	N/A	Dwelling is a recent, clad addition to the large two storey form of 37 Church Street. <b>It does not meet the threshold of contributory.</b>

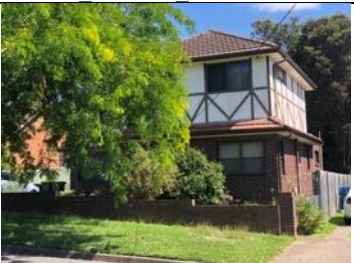
HS146 Church 39

HS146 Church 37
39	Church Avenue	<input type="checkbox"/>	<input checked="" type="checkbox"/>	<input type="checkbox"/> Poor <input type="checkbox"/> Fair <input checked="" type="checkbox"/> Good	<input checked="" type="checkbox"/> Low <input type="checkbox"/> Moderate <input type="checkbox"/> High	Original ground floor form with intrusive second storey addition, detracting from the original dwelling. <b>This item does not meet the threshold of contributory.</b>

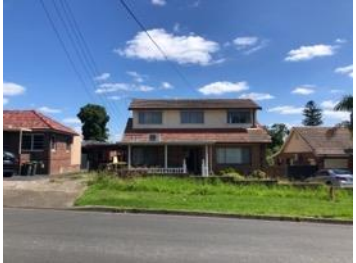
HS146 Church 45

HS146 Church 43
45	Church Avenue	<input type="checkbox"/>	<input checked="" type="checkbox"/>	<input type="checkbox"/> Poor <input checked="" type="checkbox"/> Fair <input type="checkbox"/> Good	<input checked="" type="checkbox"/> Low <input type="checkbox"/> Moderate <input type="checkbox"/> High	Considerably altered red brick dwelling with an intrusive second storey, timber clad addition. Timber windows replaced with aluminium slider windows. An additional verandah has been constructed with white railings and posts. <b>It does not meet the threshold of contributory.</b>

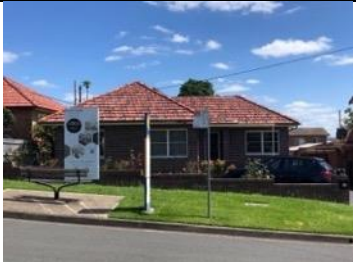
47	Church Avenue	<input checked="" type="checkbox"/>	<input type="checkbox"/>	<input type="checkbox"/> Poor <input type="checkbox"/> Fair <input checked="" type="checkbox"/> Good	<input type="checkbox"/> Low <input type="checkbox"/> Moderate <input checked="" type="checkbox"/> High	Red brick dwelling consistent with scale and form of HCA, with terracotta roof, original timber windows and aluminium flyscreen. <b>This item contributes to the conservation area.</b>

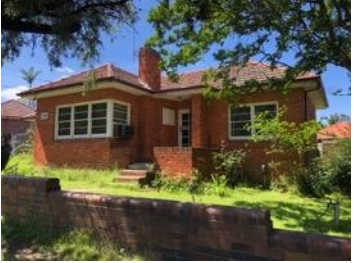
Number	Street	Contributory	Non-Contributory	Condition	Integrity	Comments	Photograph and reference number
1	Fenwick Place	<input checked="" type="checkbox"/>	<input type="checkbox"/>	<input type="checkbox"/> Poor <input type="checkbox"/> Fair <input checked="" type="checkbox"/> Good	<input type="checkbox"/> Low <input type="checkbox"/> Moderate <input checked="" type="checkbox"/> High	Red brick dwelling consistent with scale and form of HCA, with terracotta roof and original timber windows. <b>This item contributes to the conservation area.</b>

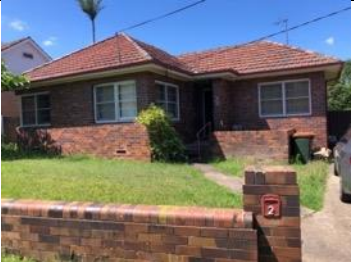
HS146 Fenwick 2

HS146 Fenwick 1
2	Fenwick Place	<input checked="" type="checkbox"/>	<input type="checkbox"/>	<input type="checkbox"/> Poor <input type="checkbox"/> Fair <input checked="" type="checkbox"/> Good	<input type="checkbox"/> Low <input type="checkbox"/> Moderate <input checked="" type="checkbox"/> High	Red brick dwelling consistent with scale and form of HCA, with terracotta roof and original timber windows. <b>This item contributes to the conservation area.</b>

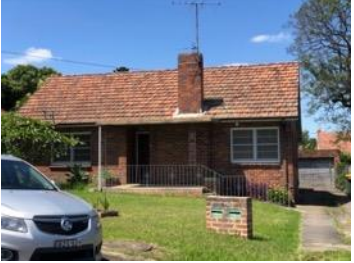
Number	Street	Contributory	Non-Contributory	Condition	Integrity	Comments	Photograph and reference number
5A	Fenwick Place	<input checked="" type="checkbox"/>	<input type="checkbox"/>	<input type="checkbox"/> Poor <input type="checkbox"/> Fair <input checked="" type="checkbox"/> Good	<input type="checkbox"/> Low <input type="checkbox"/> Moderate <input checked="" type="checkbox"/> High	Red brick dwelling consistent with scale and form of HCA, with terracotta roof and original timber windows. <b>This item contributes to the conservation area.</b>

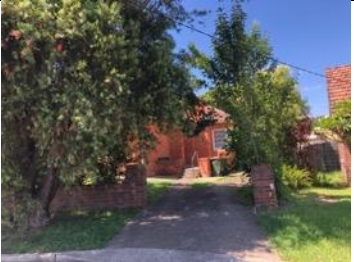
6	Fenwick Place	<input checked="" type="checkbox"/>	<input type="checkbox"/>	<input type="checkbox"/> Poor <input type="checkbox"/> Fair <input checked="" type="checkbox"/> Good	<input type="checkbox"/> Low <input type="checkbox"/> Moderate <input checked="" type="checkbox"/> High	Red brick dwelling consistent with scale and form of HCA, with terracotta roof and original timber windows. <b>This item contributes to the conservation area.</b>

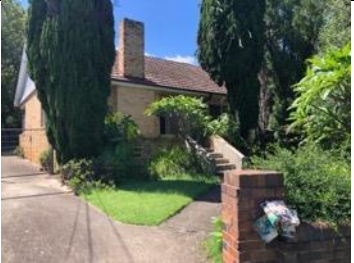
HS146 Fenwick 7

HS146 Fenwick 6
7	Fenwick Place	<input checked="" type="checkbox"/>	<input type="checkbox"/>	<input type="checkbox"/> Poor <input type="checkbox"/> Fair <input checked="" type="checkbox"/> Good	<input type="checkbox"/> Low <input type="checkbox"/> Moderate <input checked="" type="checkbox"/> High	Blonde brick dwelling consistent with scale and form of HCA, with terracotta roof and original timber windows. <b>This item contributes to the conservation area.</b>

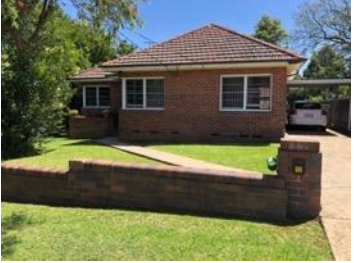
Number	Street	Contributory	Non-Contributory	Condition	Integrity	Comments	Photograph and reference number
12	Fenwick Place	<input checked="" type="checkbox"/>	<input type="checkbox"/>	<input type="checkbox"/> Poor <input checked="" type="checkbox"/> Fair <input type="checkbox"/> Good	<input type="checkbox"/> Low <input type="checkbox"/> Moderate <input checked="" type="checkbox"/> High	Red brick dwelling consistent with scale and form of HCA, with terracotta roof and original timber windows. <b>This item contributes to the conservation area.</b>

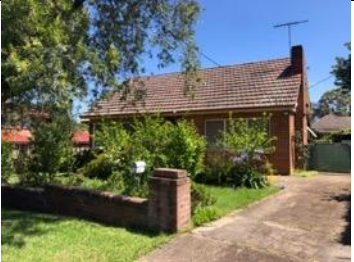
HS146 Fenwick 13

HS146 Fenwick 12
13	Fenwick Place	<input checked="" type="checkbox"/>	<input type="checkbox"/>	<input type="checkbox"/> Poor <input type="checkbox"/> Fair <input checked="" type="checkbox"/> Good	<input type="checkbox"/> Low <input type="checkbox"/> Moderate <input checked="" type="checkbox"/> High	Red brick dwelling consistent with scale and form of HCA, with terracotta roof and original timber windows. <b>This item contributes to the conservation area.</b>

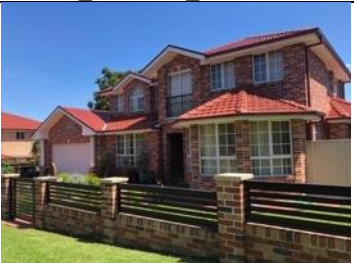
14	Fenwick Place	<input type="checkbox"/>	<input checked="" type="checkbox"/>	N/A	N/A	Non-contributory item that is a two storey, ca. early 21 <sup>st</sup> Century dwelling, with red bricks and terracotta roof tiles. Window frames are replica multi-pane frames. <b>This item does not meet the threshold of contributory.</b>

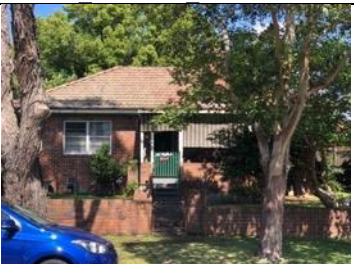
HS146 Gowrie 1

HS146 Fenwick 14
1	Gowrie Crescent	<input checked="" type="checkbox"/>	<input type="checkbox"/>	<input type="checkbox"/> Poor <input type="checkbox"/> Fair <input checked="" type="checkbox"/> Good	<input type="checkbox"/> Low <input type="checkbox"/> Moderate <input checked="" type="checkbox"/> High	Red brick dwelling consistent with scale and form of HCA, with terracotta roof and original timber windows. <b>This item contributes to the conservation area.</b>

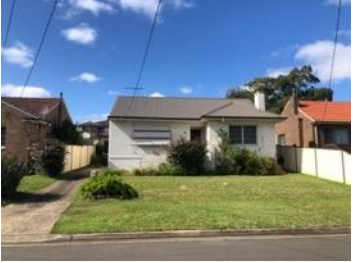
Number	Street	Contributory	Non-Contributory	Condition	Integrity	Comments	Photograph and reference number
6	Gowrie Crescent	<input checked="" type="checkbox"/>	<input type="checkbox"/>	<input type="checkbox"/> Poor <input type="checkbox"/> Fair <input checked="" type="checkbox"/> Good	<input type="checkbox"/> Low <input type="checkbox"/> Moderate <input checked="" type="checkbox"/> High	Brick dwelling consistent with scale and form of HCA, with painted bricks. Includes terracotta roof and original timber windows. <b>This item contributes to the conservation area.</b>

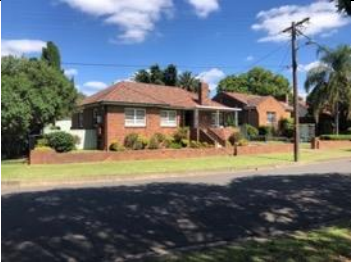
HS146 Gowrie 7

HS146 Gowrie 6
7	Gowrie Crescent	<input checked="" type="checkbox"/>	<input type="checkbox"/>	<input type="checkbox"/> Poor <input type="checkbox"/> Fair <input checked="" type="checkbox"/> Good	<input type="checkbox"/> Low <input type="checkbox"/> Moderate <input checked="" type="checkbox"/> High	Red brick dwelling consistent with scale and form of HCA, with terracotta roof and original timber windows. The well-kept garden further contributes to its aesthetic appeal. <b>This item contributes to the conservation area.</b>

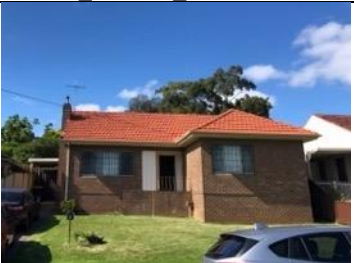
8	Gowrie Crescent	<input type="checkbox"/>	<input checked="" type="checkbox"/>	<input type="checkbox"/> Poor <input checked="" type="checkbox"/> Fair <input type="checkbox"/> Good	<input checked="" type="checkbox"/> Low <input type="checkbox"/> Moderate <input type="checkbox"/> High	Red brick dwelling with possible addition constructed to the front, introducing a gabled roof form. Original window to the left altered with aluminium frames, door and opening altered. <b>This item does not contribute to the conservation area.</b>

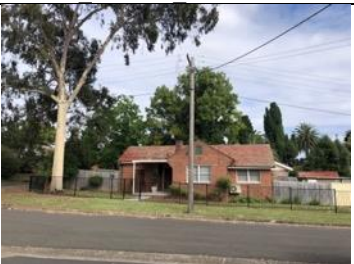
HS146 Gowrie 9

HS146 Gowrie 8
9	Gowrie Crescent	<input checked="" type="checkbox"/>	<input type="checkbox"/>	<input type="checkbox"/> Poor <input type="checkbox"/> Fair <input checked="" type="checkbox"/> Good	<input type="checkbox"/> Low <input type="checkbox"/> Moderate <input checked="" type="checkbox"/> High	Red brick dwelling consistent with scale and form of HCA, with terracotta roof and original timber windows. <b>This item contributes to the conservation area.</b>
