## Peer Review

Review of Comprehensive Heritage Study Proposed

Cumberland Heritage List – Westmead Only

Cumberland City Council

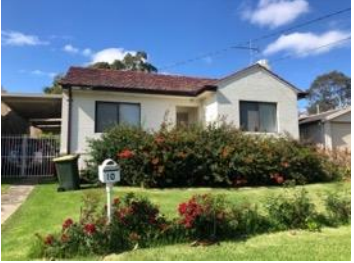
Number	Street	Contributory	Non-Contributory	Condition	Integrity	Comments	Photograph and reference number
10	Gowrie Crescent	<input checked="" type="checkbox"/>	<input type="checkbox"/>	<input type="checkbox"/> Poor <input type="checkbox"/> Fair <input checked="" type="checkbox"/> Good	<input type="checkbox"/> Low <input checked="" type="checkbox"/> Moderate <input type="checkbox"/> High	Painted brick dwelling consistent with scale and form of HCA, with terracotta roof and aluminium window frames in place of original timber windows. <b>This item contributes to the conservation area.</b>

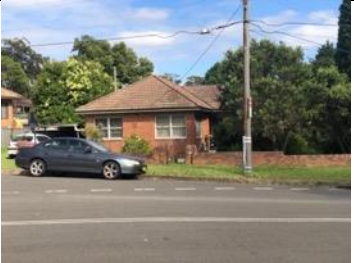
HS146 Gowrie 11

HS146 Gowrie 10
11	Gowrie Crescent	<input checked="" type="checkbox"/>	<input type="checkbox"/>	<input type="checkbox"/> Poor <input type="checkbox"/> Fair <input checked="" type="checkbox"/> Good	<input type="checkbox"/> Low <input type="checkbox"/> Moderate <input checked="" type="checkbox"/> High	Red brick dwelling consistent with scale and form of HCA, with terracotta roof and original timber windows. <b>This item contributes to the conservation area.</b>

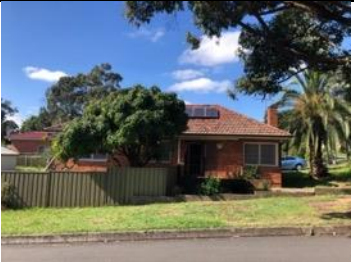
12	Gowrie Crescent	<input checked="" type="checkbox"/>	<input type="checkbox"/>	<input type="checkbox"/> Poor <input type="checkbox"/> Fair <input checked="" type="checkbox"/> Good	<input type="checkbox"/> Low <input type="checkbox"/> Moderate <input checked="" type="checkbox"/> High	Red brick dwelling consistent with scale and form of HCA, with terracotta roof and original timber windows obscured with a metal security grill. <b>This item contributes to the conservation area.</b>

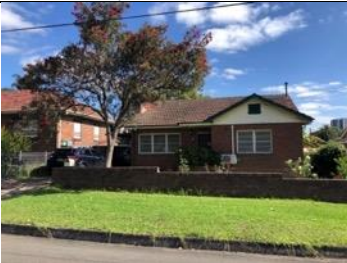
HS146 Gowrie 17

HS146_Gowrie_15 (image captured from Google Streetview)
17	Gowrie Crescent	<input checked="" type="checkbox"/>	<input type="checkbox"/>	<input type="checkbox"/> Poor <input type="checkbox"/> Fair <input checked="" type="checkbox"/> Good	<input type="checkbox"/> Low <input type="checkbox"/> Moderate <input checked="" type="checkbox"/> High	Red brick dwelling consistent with scale and form of HCA, with terracotta roof and original timber windows. <b>This item contributes to the conservation area.</b>

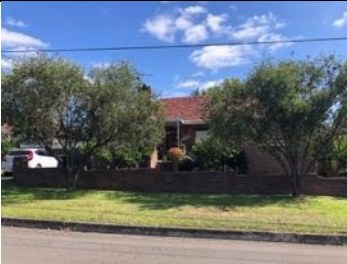
19	Gowrie Crescent	<input checked="" type="checkbox"/>	<input type="checkbox"/>	<input type="checkbox"/> Poor <input type="checkbox"/> Fair <input checked="" type="checkbox"/> Good	<input type="checkbox"/> Low <input checked="" type="checkbox"/> Moderate <input type="checkbox"/> High	Red brick dwelling consistent with scale and form of HCA, with terracotta roof. Original form is maintained although roller shutters have been installed to windows. <b>This item contributes to the conservation area.</b>

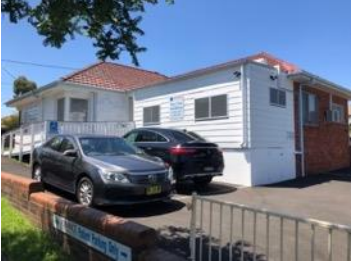
HS146 Gowrie 19
72	Hawkesbury Road	<input type="checkbox"/>	<input checked="" type="checkbox"/>	<input type="checkbox"/> Poor <input checked="" type="checkbox"/> Fair <input type="checkbox"/> Good	<input checked="" type="checkbox"/> Low <input type="checkbox"/> Moderate <input type="checkbox"/> High	Originally a dwelling consistent with the form and scale of the HCA although it has been considerably altered (painted and rendered with aluminium window frames) for use as a medical centre with an addition to the north (Nolan Crescent). <b>This item does not meet</b>

Number	Street	Contributory	Non-Contributory	Condition	Integrity	Comments	Photograph and reference number
						the threshold of contributory. Given the location of the property on the HCA boundary, it is possible to consider it for removal from the HCA.

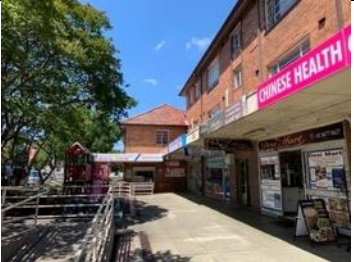
HS146 Hawkesbury 72(2)
74	Hawkesbury Road	<input checked="" type="checkbox"/>	<input type="checkbox"/>	<input type="checkbox"/> Poor <input type="checkbox"/> Fair <input checked="" type="checkbox"/> Good	<input type="checkbox"/> Low <input checked="" type="checkbox"/> Moderate <input type="checkbox"/> High	<b>Potential heritage item.</b> Contributory to the HCA as an example of the commercial dwellings of the ca. 1944 construction era.

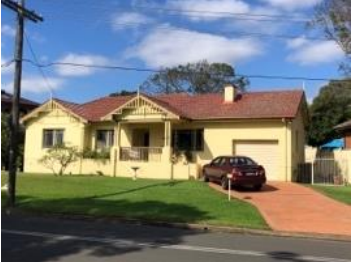
HS146_Macarthur_28

28	Macarthur Crescent	<input type="checkbox"/>	<input checked="" type="checkbox"/>	<input type="checkbox"/> Poor <input checked="" type="checkbox"/> Fair <input type="checkbox"/> Good	<input checked="" type="checkbox"/> Low <input type="checkbox"/> Moderate <input type="checkbox"/> High	The dwelling is single storey with a rendered finish to walls and aluminium windows. Possibly constructed in later 20 <sup>th</sup> century to reference earlier the earlier character. Window form, gable treatment and garage are intrusive. <b>This item does not contribute to the HCA.</b> Given the location of the property on the HCA boundary, it is possible to consider it for removal from the HCA.

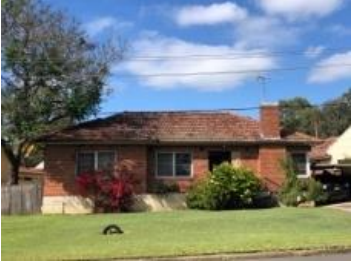
Number	Street	Contributory	Non-Contributory	Condition	Integrity	Comments	Photograph and reference number
30	Macarthur Crescent	<input checked="" type="checkbox"/>	<input type="checkbox"/>	<input type="checkbox"/> Poor <input type="checkbox"/> Fair <input checked="" type="checkbox"/> Good	<input type="checkbox"/> Low <input type="checkbox"/> Moderate <input checked="" type="checkbox"/> High	Red brick dwelling consistent with scale and form of HCA, with terracotta roof and original timber windows. <b>This item contributes to the conservation area.</b>

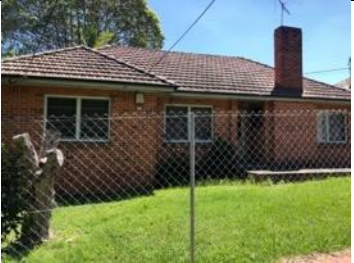
HS146 Nolan 1

HS146 Macarthur 30
1	Nolan Crescent	<input checked="" type="checkbox"/>	<input type="checkbox"/>	<input type="checkbox"/> Poor <input checked="" type="checkbox"/> Fair <input type="checkbox"/> Good	<input type="checkbox"/> Low <input type="checkbox"/> Moderate <input checked="" type="checkbox"/> High	Red brick dwelling consistent with scale and form of HCA, with terracotta roof and original timber windows covered with aluminium fly screen. <b>This item contributes to the conservation area.</b>

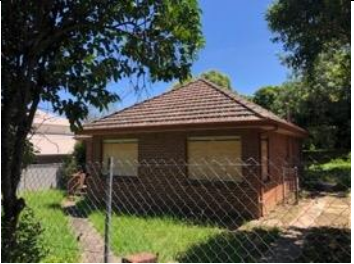
HS146 Nolan 3

HS146 Nolan 2
3	Nolan Crescent	<input checked="" type="checkbox"/>	<input type="checkbox"/>	<input type="checkbox"/> Poor <input checked="" type="checkbox"/> Fair <input type="checkbox"/> Good	<input type="checkbox"/> Low <input checked="" type="checkbox"/> Moderate <input type="checkbox"/> High	Dwelling appears to be vacant with windows boarded up (timber has been secured over the windows and front door). The dwelling otherwise appears to be in a sound condition and is consistent with the built form of the proposed HCA. <b>This item contributes to the conservation area.</b>

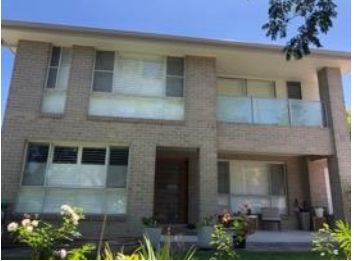
HS146 Nolan 4
5	Nolan Crescent	<input type="checkbox"/>	<input checked="" type="checkbox"/>	N/A	N/A	Dwelling is a two storey, 21 <sup>st</sup> century structure that does not reference any design characteristics of the surrounding area. <b>This item does not meet the threshold of contributory.</b>

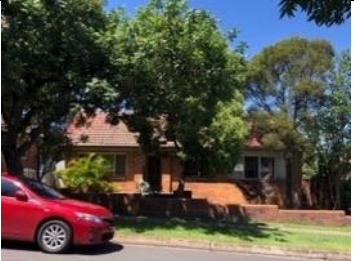
HS146 Nolan 6

HS146 Nolan 5
6	Nolan Crescent	<input checked="" type="checkbox"/>	<input type="checkbox"/>	<input type="checkbox"/> Poor <input type="checkbox"/> Fair <input checked="" type="checkbox"/> Good	<input type="checkbox"/> Low <input checked="" type="checkbox"/> Moderate <input type="checkbox"/> High	Red brick dwelling consistent with scale and form of HCA, with terracotta roof and aluminium window frames in place of original timber windows. <b>This item contributes to the conservation area.</b>

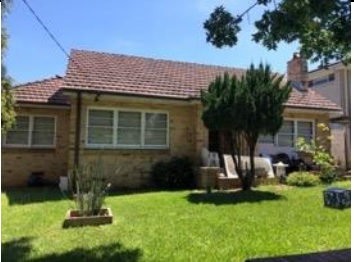
HS146 Nolan 7

7	Nolan Crescent	<input checked="" type="checkbox"/>	<input type="checkbox"/>	<input type="checkbox"/> Poor <input checked="" type="checkbox"/> Fair <input type="checkbox"/> Good	<input type="checkbox"/> Low <input checked="" type="checkbox"/> Moderate <input type="checkbox"/> High	Blonde brick dwelling consistent with scale and form of HCA, with terracotta roof and original timber windows. Addition to the side is set back and doesn't significantly detract from the building. <b>This item contributes to the conservation area.</b>

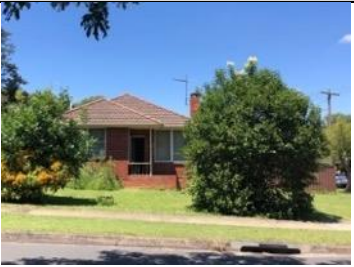
Number	Street	Contributory	Non-Contributory	Condition	Integrity	Comments	Photograph and reference number
8	Nolan Crescent	<input checked="" type="checkbox"/>	<input type="checkbox"/>	<input type="checkbox"/> Poor <input type="checkbox"/> Fair <input checked="" type="checkbox"/> Good	<input type="checkbox"/> Low <input type="checkbox"/> Moderate <input checked="" type="checkbox"/> High	Red brick dwelling consistent with scale and form of HCA, with terracotta roof, original timber windows and aluminium flyscreen. <b>This item contributes to the conservation area.</b>

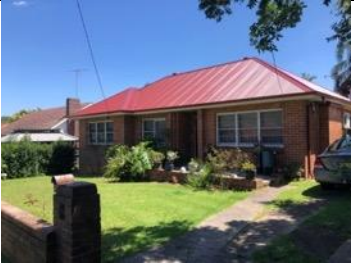
HS146 Nolan 9

HS146 Nolan 8
9	Nolan Crescent	<input checked="" type="checkbox"/>	<input type="checkbox"/>	<input type="checkbox"/> Poor <input type="checkbox"/> Fair <input checked="" type="checkbox"/> Good	<input type="checkbox"/> Low <input checked="" type="checkbox"/> Moderate <input type="checkbox"/> High	Red brick dwelling consistent with scale and form of HCA, with original timber windows and aluminium flyscreen. Metal sheet roofing likely replaced an earlier terracotta tiled roof. <b>This item contributes to the conservation area.</b>

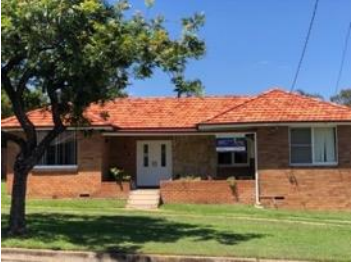
10	Nolan Crescent	<input checked="" type="checkbox"/>	<input type="checkbox"/>	<input type="checkbox"/> Poor <input type="checkbox"/> Fair <input checked="" type="checkbox"/> Good	<input type="checkbox"/> Low <input checked="" type="checkbox"/> Moderate <input type="checkbox"/> High	Single storey dwelling with red brick and intrusive stone finish to the entry. Windows have been altered to large format aluminium windows. <b>This item contributes to the conservation area.</b>

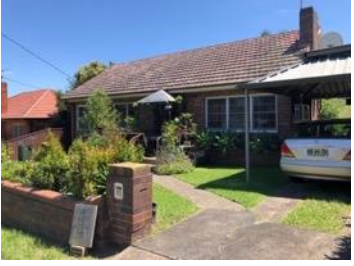
HS146 Nolan 11

HS146 Nolan 10
11	Nolan Crescent	<input checked="" type="checkbox"/>	<input type="checkbox"/>	<input type="checkbox"/> Poor <input type="checkbox"/> Fair <input checked="" type="checkbox"/> Good	<input type="checkbox"/> Low <input checked="" type="checkbox"/> Moderate <input type="checkbox"/> High	Red brick dwelling consistent with scale and form of HCA, with terracotta roof and aluminium windows replacing the original timber windows. <b>This item contributes to the conservation area.</b>

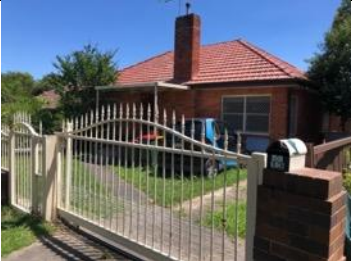
HS146 Nolan 13

Number	Street	Contributory	Non-Contributory	Condition	Integrity	Comments	Photograph and reference number
12	Nolan Crescent	<input checked="" type="checkbox"/>	<input type="checkbox"/>	<input type="checkbox"/> Poor <input type="checkbox"/> Fair <input checked="" type="checkbox"/> Good	<input type="checkbox"/> Low <input type="checkbox"/> Moderate <input checked="" type="checkbox"/> High	Red brick dwelling consistent with scale and form of HCA, with terracotta roof and original timber windows. <b>This item contributes to the conservation area.</b>	  HS146 Nolan 12
13	Nolan Crescent	<input checked="" type="checkbox"/>	<input type="checkbox"/>	<input type="checkbox"/> Poor <input type="checkbox"/> Fair <input checked="" type="checkbox"/> Good	<input type="checkbox"/> Low <input checked="" type="checkbox"/> Moderate <input type="checkbox"/> High	Red brick dwelling consistent with scale and form of HCA, with terracotta roof and aluminium windows replacing the original timber windows. The front fence and gate are intrusive but reversible. <b>This item contributes to the conservation area.</b>

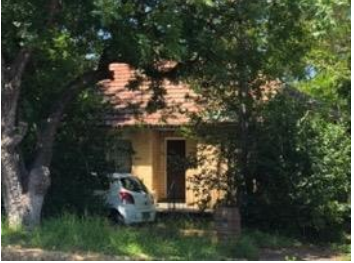
Number	Street	Contributory	Non-Contributory	Condition	Integrity	Comments	Photograph and reference number
16	Nolan Crescent	<input checked="" type="checkbox"/>	<input type="checkbox"/>	<input type="checkbox"/> Poor <input checked="" type="checkbox"/> Fair <input type="checkbox"/> Good	<input type="checkbox"/> Low <input checked="" type="checkbox"/> Moderate <input type="checkbox"/> High	Blonde brick dwelling consistent with scale and form of HCA, with terracotta roof and original timber windows. Overgrown garden detracts from its setting. <b>This item contributes to the conservation area.</b>

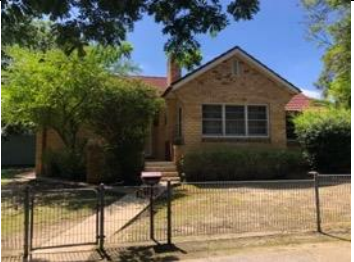
HS146 Nolan 17

HS146 Nolan 16
17	Nolan Crescent	<input checked="" type="checkbox"/>	<input type="checkbox"/>	<input type="checkbox"/> Poor <input type="checkbox"/> Fair <input checked="" type="checkbox"/> Good	<input type="checkbox"/> Low <input type="checkbox"/> Moderate <input checked="" type="checkbox"/> High	Blonde brick dwelling consistent with scale and form of HCA, with terracotta roof and original timber windows. <b>This item contributes to the conservation area.</b>

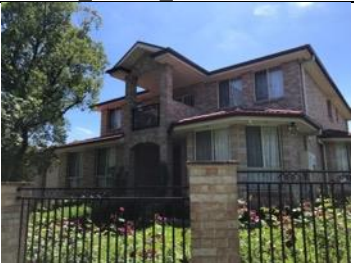
19	Nolan Crescent	<input type="checkbox"/>	<input checked="" type="checkbox"/>	N/A	N/A	<b>Noted as contributory in HCA Study.</b> Dwelling is a late 20 <sup>th</sup> century/early 21 <sup>st</sup> century, two storey structure. <b>This item does not meet the threshold of contributory.</b>

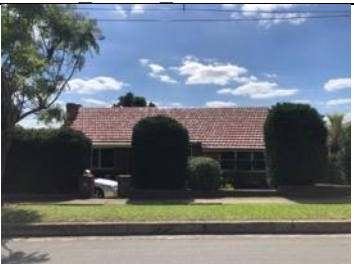
HS146 Toohey 1

HS146 Nolan 19
1	Toohey Avenue	<input checked="" type="checkbox"/>	<input type="checkbox"/>	<input type="checkbox"/> Poor <input type="checkbox"/> Fair <input checked="" type="checkbox"/> Good	<input type="checkbox"/> Low <input type="checkbox"/> Moderate <input checked="" type="checkbox"/> High	Red brick dwelling consistent with scale and form of HCA, with terracotta roof and original timber windows. This item contributes to the conservation area.

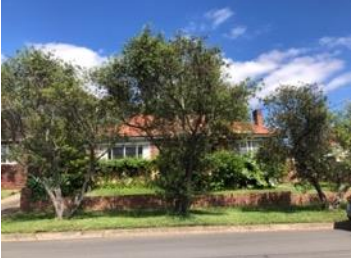
HS146 Toohey 2

HS146 Toohey 1B
2	Toohey Avenue	<input checked="" type="checkbox"/>	<input type="checkbox"/>	<input type="checkbox"/> Poor <input type="checkbox"/> Fair <input checked="" type="checkbox"/> Good	<input type="checkbox"/> Low <input type="checkbox"/> Moderate <input checked="" type="checkbox"/> High	Red brick dwelling consistent with scale and form of HCA, with rendered base, terracotta roof and original timber windows as well as aluminium windows. <b>This item contributes to the conservation area.</b>

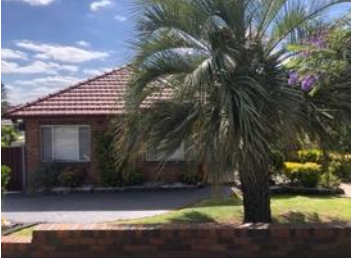
3	Toohey Avenue	<input checked="" type="checkbox"/>	<input type="checkbox"/>	<input type="checkbox"/> Poor <input type="checkbox"/> Fair <input checked="" type="checkbox"/> Good	<input type="checkbox"/> Low <input checked="" type="checkbox"/> Moderate <input type="checkbox"/> High	Red brick dwelling consistent with scale and form of HCA, with terracotta roof and aluminium window frames in place of original timber windows. <b>This item contributes to the conservation area.</b>

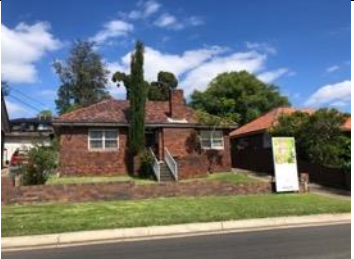
HS146 Toohey 4

HS146 Toohey 3
4	Toohey Avenue	<input checked="" type="checkbox"/>	<input type="checkbox"/>	<input type="checkbox"/> Poor <input type="checkbox"/> Fair <input checked="" type="checkbox"/> Good	<input type="checkbox"/> Low <input type="checkbox"/> Moderate <input checked="" type="checkbox"/> High	Red brick dwelling consistent with scale and form of HCA, with terracotta roof and original timber windows. <b>This item contributes to the conservation area.</b>

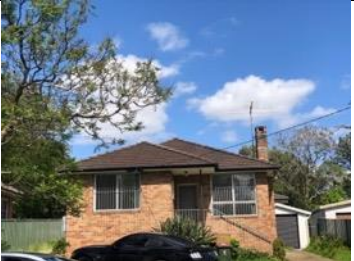
HS146 Toohey 10

HS146 Toohey 9
10	Toohey Avenue	<input checked="" type="checkbox"/>	<input type="checkbox"/>	<input type="checkbox"/> Poor <input type="checkbox"/> Fair <input checked="" type="checkbox"/> Good	<input type="checkbox"/> Low <input checked="" type="checkbox"/> Moderate <input type="checkbox"/> High	Red brick dwelling consistent with scale and form of HCA, with terracotta roof and aluminium window frames in place of original timber windows. <b>This item contributes to the conservation area.</b>

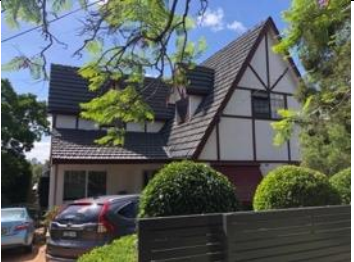
HS146 Toohey 11

11	Toohey Avenue	<input type="checkbox"/>	<input checked="" type="checkbox"/>	N/A	N/A	<b>Noted as contributory in the HCA Study.</b> It is a late 20 <sup>th</sup> Century/early 21 <sup>st</sup> Century two storey dwelling that is rendered with aluminium windows and dark tiled roof, inconsistent with HCA forms. <b>It does not meet the threshold of contributory.</b>

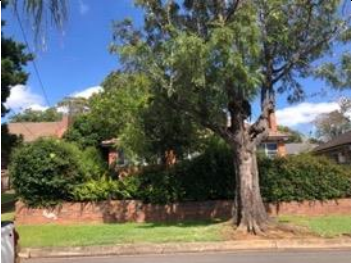
Number	Street	Contributory	Non-Contributory	Condition	Integrity	Comments	Photograph and reference number
12	Toohey Avenue	<input checked="" type="checkbox"/>	<input type="checkbox"/>	<input type="checkbox"/> Poor <input type="checkbox"/> Fair <input checked="" type="checkbox"/> Good	<input type="checkbox"/> Low <input type="checkbox"/> Moderate <input checked="" type="checkbox"/> High	Red brick dwelling consistent with scale and form of HCA, with terracotta roof and aluminium and original timber windows. <b>This item contributes to the conservation area.</b>

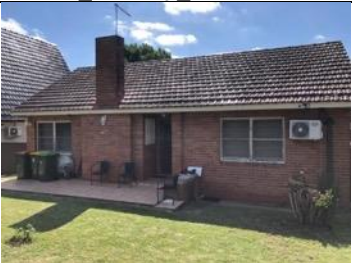
HS146 Toohey 13

HS146 Toohey 12
13	Toohey Avenue	<input checked="" type="checkbox"/>	<input type="checkbox"/>	<input type="checkbox"/> Poor <input checked="" type="checkbox"/> Fair <input type="checkbox"/> Good	<input type="checkbox"/> Low <input type="checkbox"/> Moderate <input checked="" type="checkbox"/> High	<b>Noted as non-contributory in HCA Study.</b> Conforms to the ca. 1944 era of design with red brick, single storey form, terracotta roof and original timber windows. <b>This item contributes to the conservation area.</b>

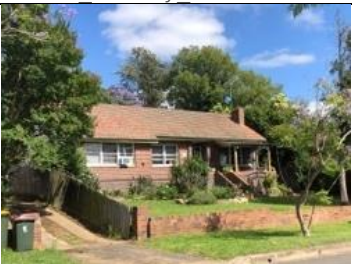
14	Toohey Avenue	<input checked="" type="checkbox"/>	<input type="checkbox"/>	<input type="checkbox"/> Poor <input type="checkbox"/> Fair <input checked="" type="checkbox"/> Good	<input type="checkbox"/> Low <input type="checkbox"/> Moderate <input checked="" type="checkbox"/> High	Red brick dwelling consistent with scale and form of HCA, with terracotta roof and original timber windows. <b>This item contributes to the conservation area.</b>

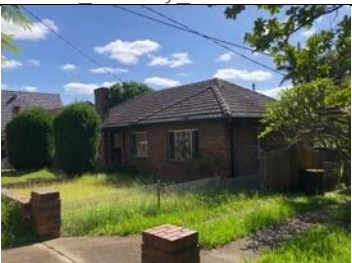
HS146 Toohey 15

HS146 Toohey 14
15	Toohey Avenue	<input checked="" type="checkbox"/>	<input type="checkbox"/>	<input type="checkbox"/> Poor <input type="checkbox"/> Fair <input checked="" type="checkbox"/> Good	<input type="checkbox"/> Low <input checked="" type="checkbox"/> Moderate <input type="checkbox"/> High	Red brick dwelling consistent with scale and form of HCA, with terracotta roof and aluminium window frames in <b>place of original timber windows.</b> <b>This item contributes to the conservation area.</b>

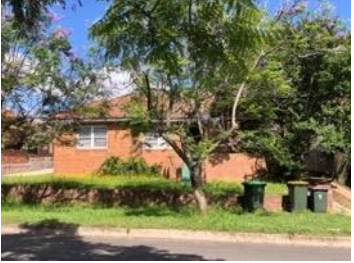
Number	Street	Contributory	Non-Contributory	Condition	Integrity	Comments	Photograph and reference number
16	Toohey Avenue	<input checked="" type="checkbox"/>	<input type="checkbox"/>	<input type="checkbox"/> Poor <input type="checkbox"/> Fair <input checked="" type="checkbox"/> Good	<input type="checkbox"/> Low <input type="checkbox"/> Moderate <input checked="" type="checkbox"/> High	Red brick dwelling consistent with scale and form of HCA, with terracotta roof and original timber windows. <b>This item contributes to the conservation area.</b>

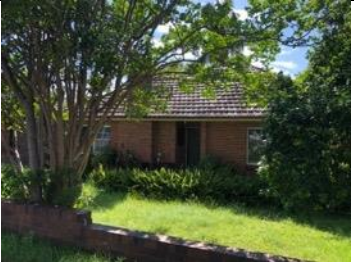
HS146 Toohey 17

HS146 Toohey 16
17	Toohey Avenue	<input checked="" type="checkbox"/>	<input type="checkbox"/>	<input type="checkbox"/> Poor <input type="checkbox"/> Fair <input checked="" type="checkbox"/> Good	<input type="checkbox"/> Low <input type="checkbox"/> Moderate <input checked="" type="checkbox"/> High	Red brick dwelling consistent with scale and form of HCA, with terracotta roof and original timber windows. <b>This item contributes to the conservation area.</b>

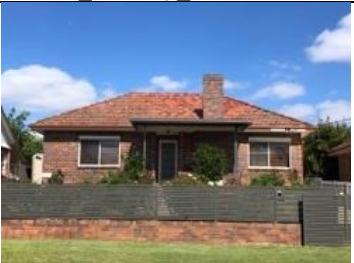
18	Toohey Avenue	<input checked="" type="checkbox"/>	<input type="checkbox"/>	<input type="checkbox"/> Poor <input type="checkbox"/> Fair <input checked="" type="checkbox"/> Good	<input type="checkbox"/> Low <input checked="" type="checkbox"/> Moderate <input type="checkbox"/> High	Red brick dwelling consistent with scale and form of HCA, with terracotta roof and aluminium window frames in place of original timber windows. <b>This item contributes to the conservation area.</b>

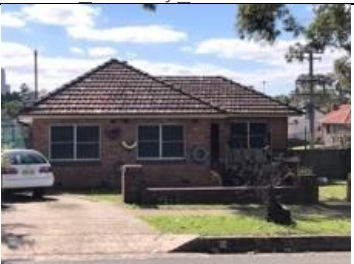
HS146 Toohey 19

HS146 Toohey 18
19	Toohey Avenue	<input checked="" type="checkbox"/>	<input type="checkbox"/>	<input type="checkbox"/> Poor <input type="checkbox"/> Fair <input checked="" type="checkbox"/> Good	<input type="checkbox"/> Low <input type="checkbox"/> Moderate <input checked="" type="checkbox"/> High	Red brick dwelling consistent with scale and form of HCA, with terracotta roof and original timber windows covered with aluminium fly screen. <b>This item contributes to the conservation area.</b>

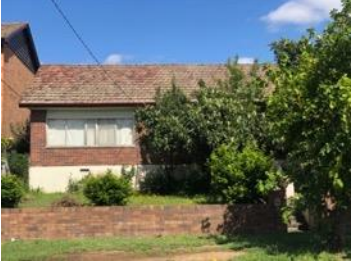
Number	Street	Contributory	Non-Contributory	Condition	Integrity	Comments	Photograph and reference number
20	Toohey Avenue	<input checked="" type="checkbox"/>	<input type="checkbox"/>	<input type="checkbox"/> Poor <input type="checkbox"/> Fair <input checked="" type="checkbox"/> Good	<input type="checkbox"/> Low <input checked="" type="checkbox"/> Moderate <input type="checkbox"/> High	Red brick dwelling with rendered base, consistent with scale and form of HCA, with terracotta roof and aluminium window frames in place of original timber windows. <b>This item contributes to the conservation area.</b>

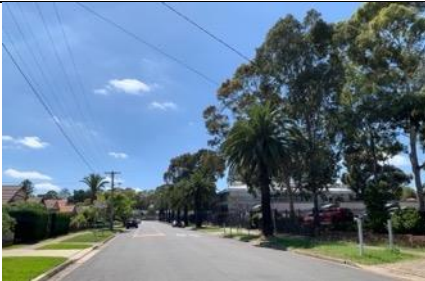
<p>HS145(12)</p>

Number	Street	Contributory	Non-Contributory	Comments	Photograph and reference number
5-19	Moree Avenue	<input checked="" type="checkbox"/>	<input type="checkbox"/>	These items are already located within the existing HCA.	
-	Moree Avenue – southern side and Grand Avenue – southern side	<input checked="" type="checkbox"/>	<input type="checkbox"/>	<p>Row of palm trees planted along the southern side of the street, with greater density along the boundary of Westmead Primary School and decreasing in density towards the western end of the street.</p> <p>Evident during the site assessment that significant planting has been established and developed over several decades, noting that more established and larger planting appears towards the rise (Grand Avenue, southern side of the road) and more recent planting is located along the</p>

Number	Street	Contributory	Non-Contributory	Comments	Photograph and reference number
				<p>bend in front of the Westmead Primary School.</p> <p>Consideration should be given to the re-establishment of planting along the entire length of the southern side road, providing infill planting where no longer evident.</p> <p>Councils' arborist should be consulted and a plan of management to be written and put in place to ensure all future planting complements the existing spacing and species.</p>
