## TOONGABBIE BRIDGE UPGRADE

Toongabbie, NSW

# GEOTECHNICAL INVESTIGATION

Job No. SYD2025-0065 | Version 0

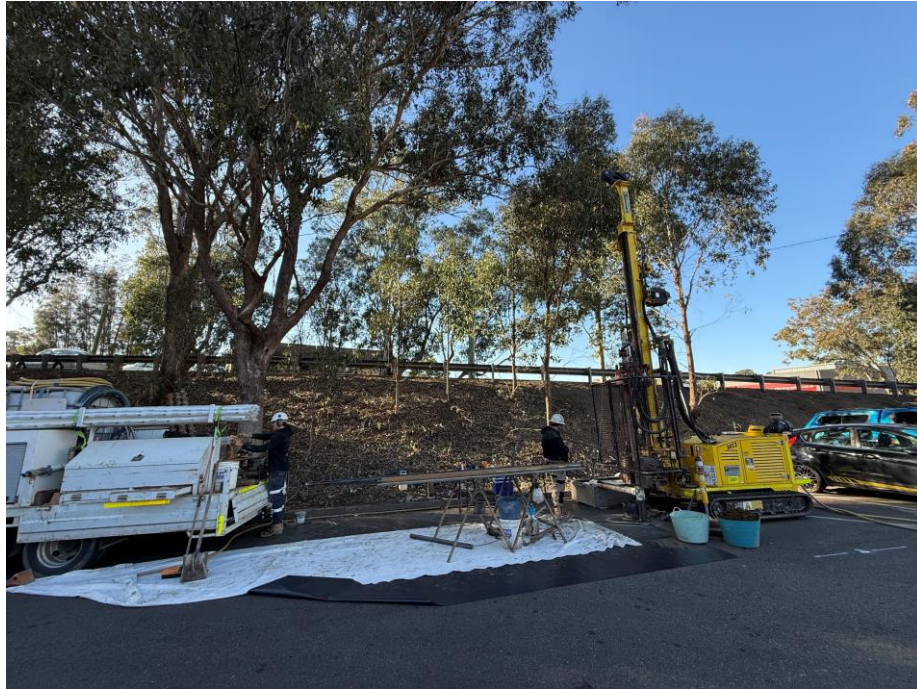
Figure 1: View looking southeast over BH01 location.

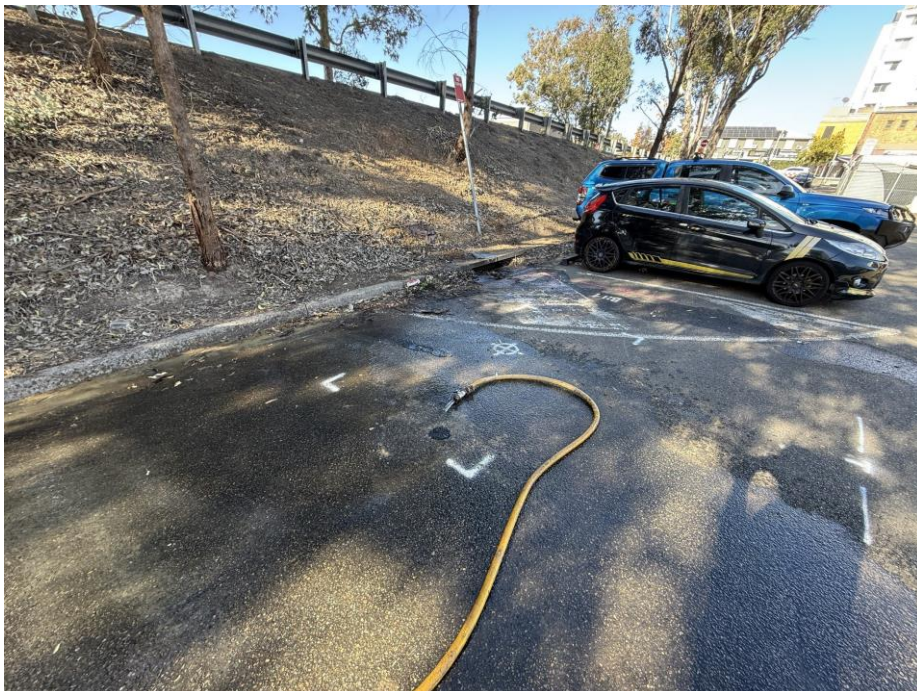
Figure 2: View looking south over BH01 location, post drilling works.

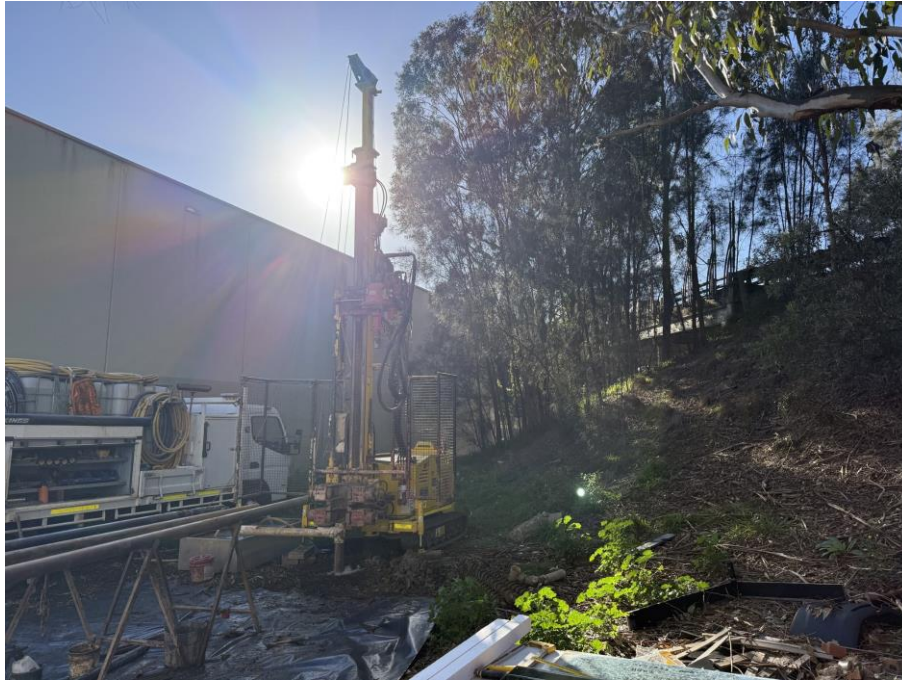
Figure 3: View looking east over BH02 location.

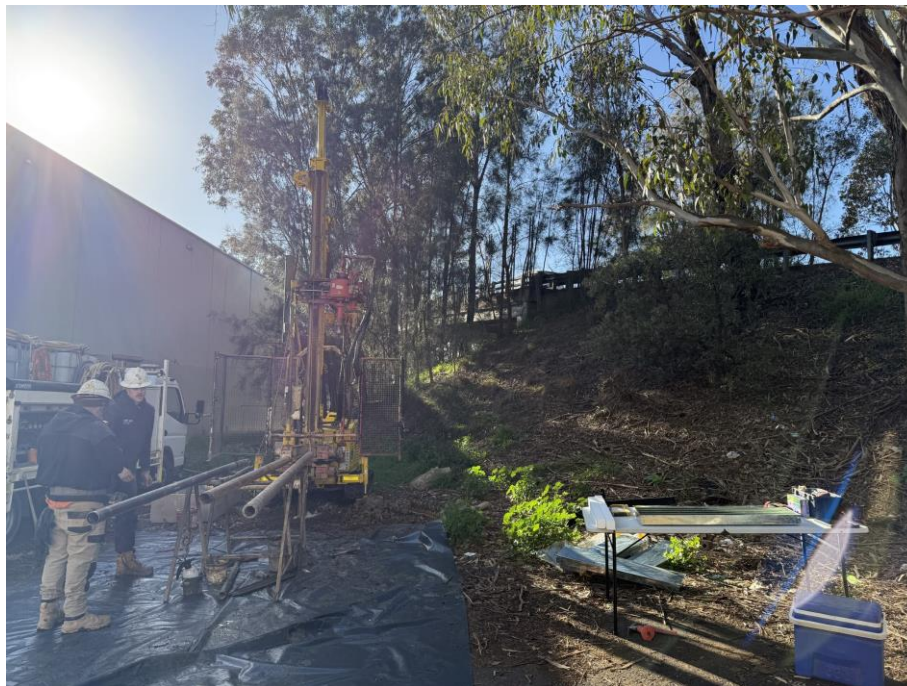
Figure 4: View looking east over BH02 location.

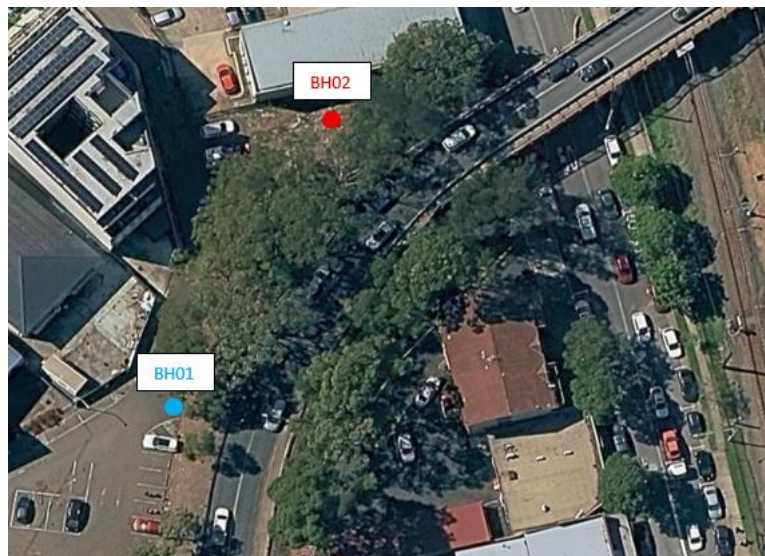
Figure 6: Approximate borehole Investigation Locations.

The approximate borehole locations are shown in Figure 6 and pavement coring locations are shown in Figure 7 below.

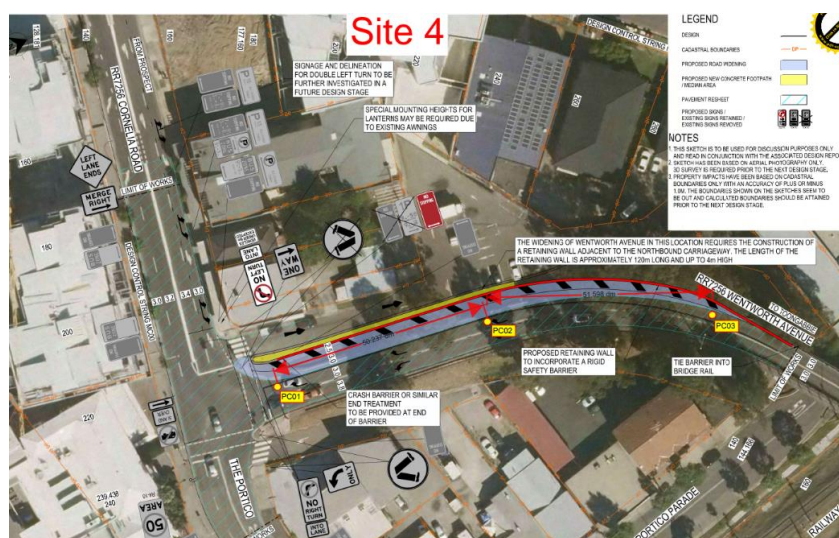
Figure 7: Approximate Pavement Coring Investigation Locations.

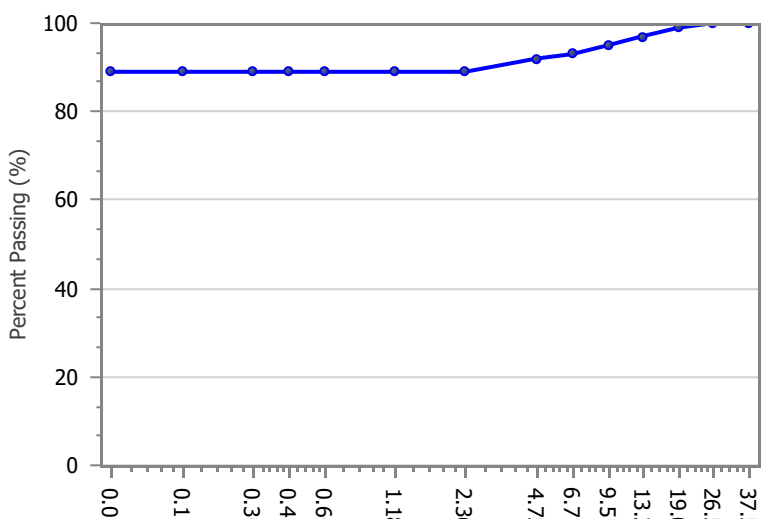
AS Sieve (mm)	Specification Minimum (%)	Percent Passing (%)	Specification Maximum (%)	<p><b>PARTICLE SIZE DISTRIBUTION GRAPH</b></p>

37.5		100		
26.5		100		
19.0		99		
13.2		97		
9.5		95		
6.7		93		
4.75		92		
2.36		89		
1.18		89		
0.600		89		
0.425		89		
0.300		89		
0.150		89		
0.075		89

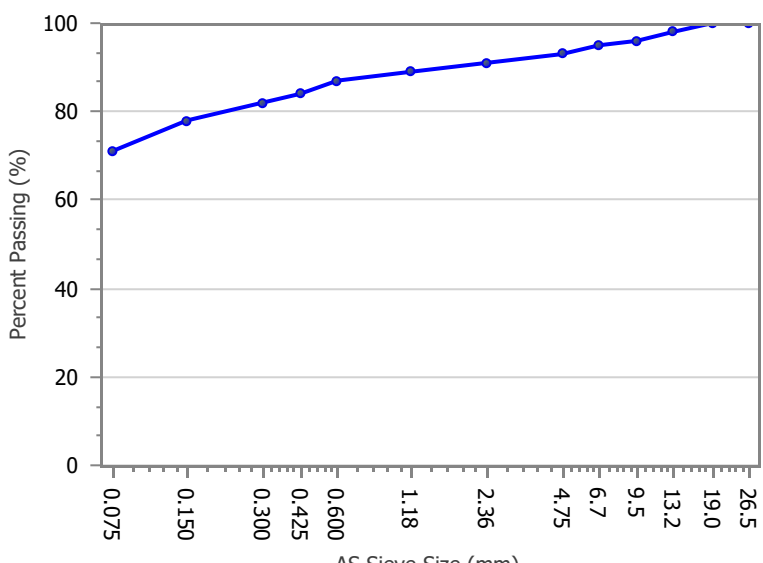
AS Sieve (mm)	Specification Minimum (%)	Percent Passing (%)	Specification Maximum (%)	<b>PARTICLE SIZE DISTRIBUTION GRAPH</b>

26.5		100		
19.0		100		
13.2		98		
9.5		96		
6.7		95		
4.75		93		
2.36		91		
1.18		89		
0.600		87		
0.425		84		
0.300		82		
0.150		78		
0.075		71

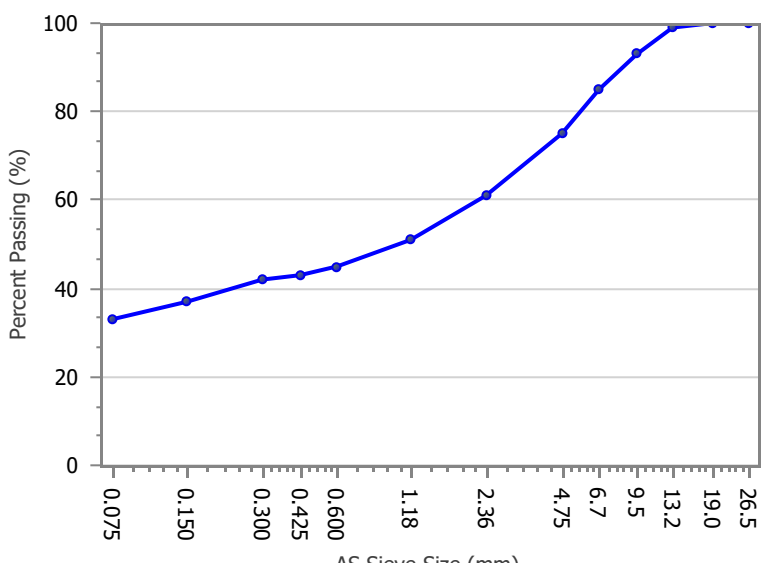
AS Sieve (mm)	Specification Minimum (%)	Percent Passing (%)	Specification Maximum (%)	<b>PARTICLE SIZE DISTRIBUTION GRAPH</b>

26.5		100		
19.0		100		
13.2		99		
9.5		93		
6.7		85		
4.75		75		
2.36		61		
1.18		51		
0.600		45		
0.425		43		
0.300		42		
0.150		37		
0.075		33

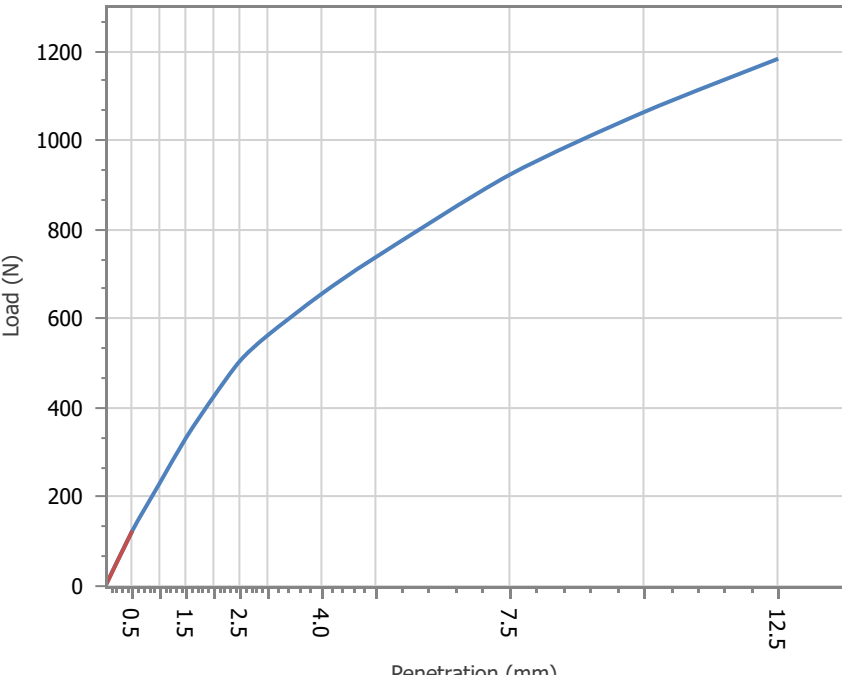
Maximum Dry Density (t/m³):	1.88	<p style="text-align: center;"><b>CBR PENETRATION PLOT</b></p>

Optimum Moisture Content (%):	15.0	
Field Moisture Content (%):	14.9	
Sample Percent Oversize (%)	1.0	
Oversize Included / Excluded	Excluded	
Target Density Ratio (%):	100	
Target Moisture Ratio (%):	100	
Placement Dry Density (t/m³):	1.88	
Placement Dry Density Ratio (%):	100.0	
Placement Moisture Content (%):	14.9	
Placement Moisture Ratio (%):	99.5	
Test Condition / Soaking Period:	Soaked / 4 Days	
CBR Surcharge (kg)	9.0	
Dry Density After Soak (t/m³):	1.85	
Total Curing Time (hrs)	140	
Liquid Limit Method	Estimation	
Moisture (top 30mm) After Soak (%)	17.4	
Moisture (remainder) After Soak (%)	15.6	
CBR Swell (%):	1.5	
Minimum CBR Specification (%):	-	
<b>CBR Value @ 2.5mm (%):</b>	<b>4.0</b>

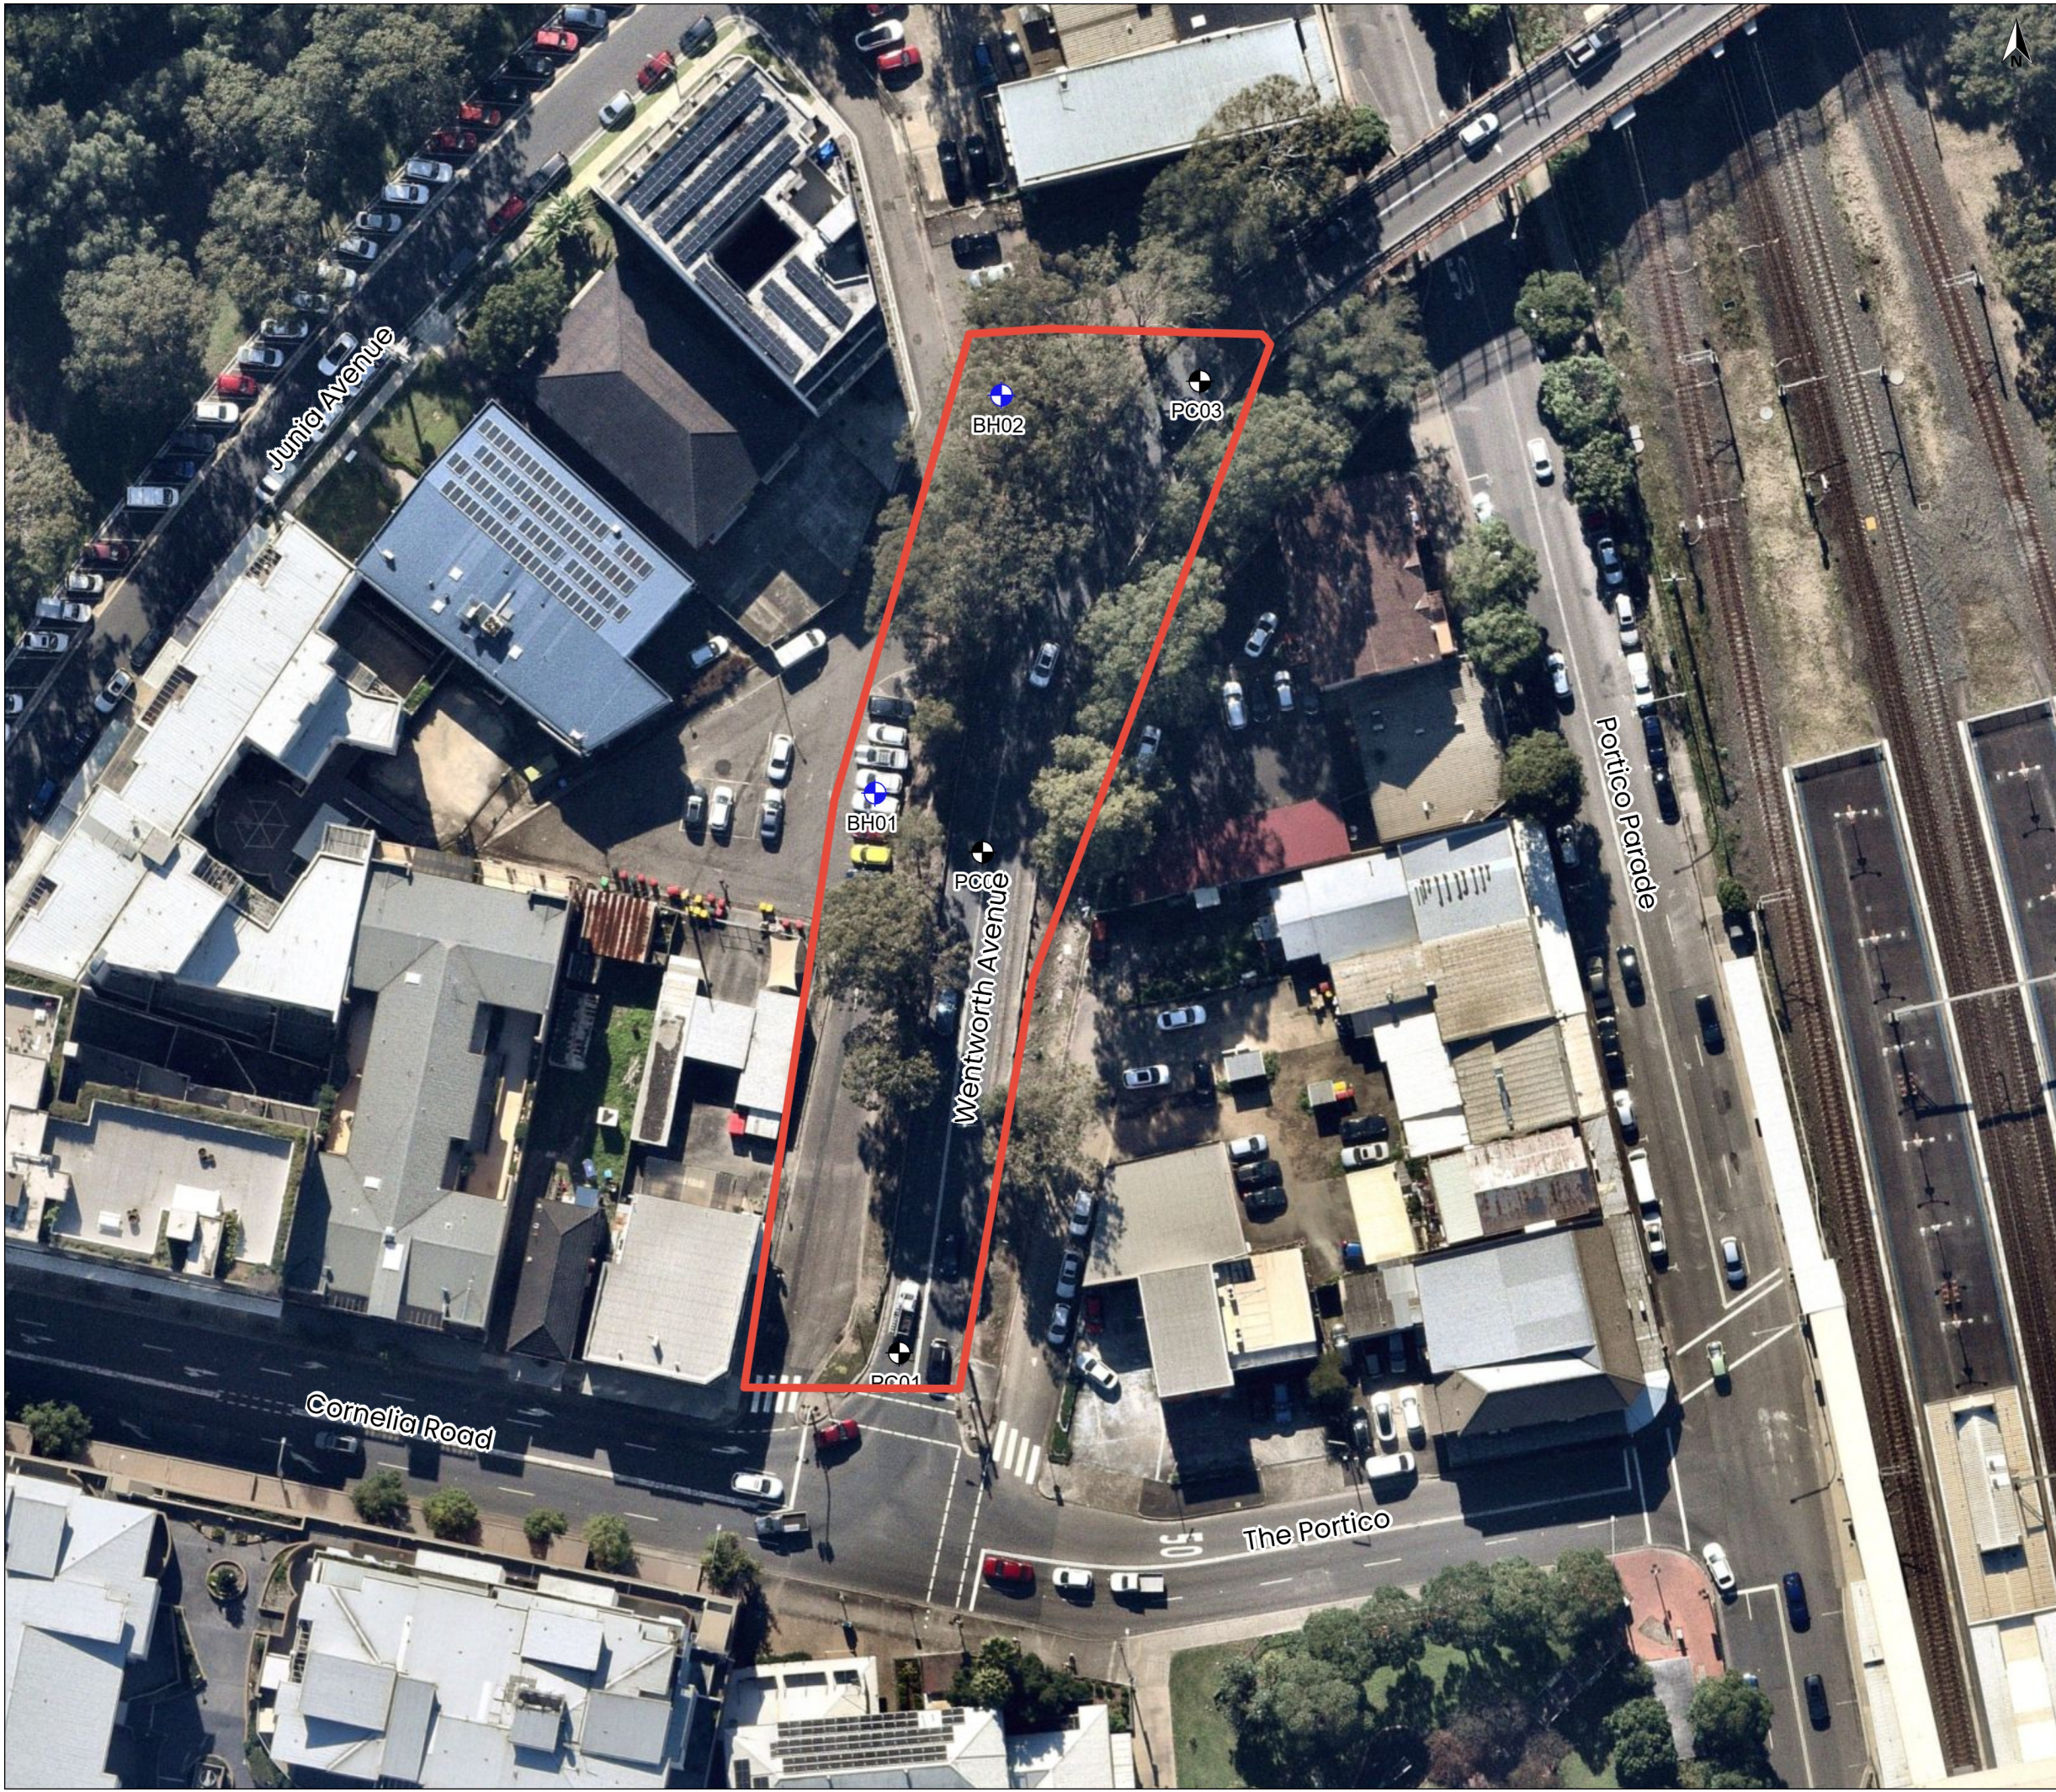
**ATTACHMENT A**  
**SAMPLE POINT LAYOUT PLAN**

- Legend**
- Approximate Investigation Area
  - Borehole Locations
  - Pavement Core Locations
