Subject: Preliminary Contamination Assessment at 2 Bachell Avenue, Lidcombe NSW

Sullivan Environmental Sciences Pty Ltd (Sullivan-ES) was engaged by Hallmark Construction Pty Ltd to conduct a Preliminary Contamination Assessment at 2 Bachell Avenue, Lidcombe NSW (the site).

Title: **Preliminary Contamination Assessment - Site Photographs**

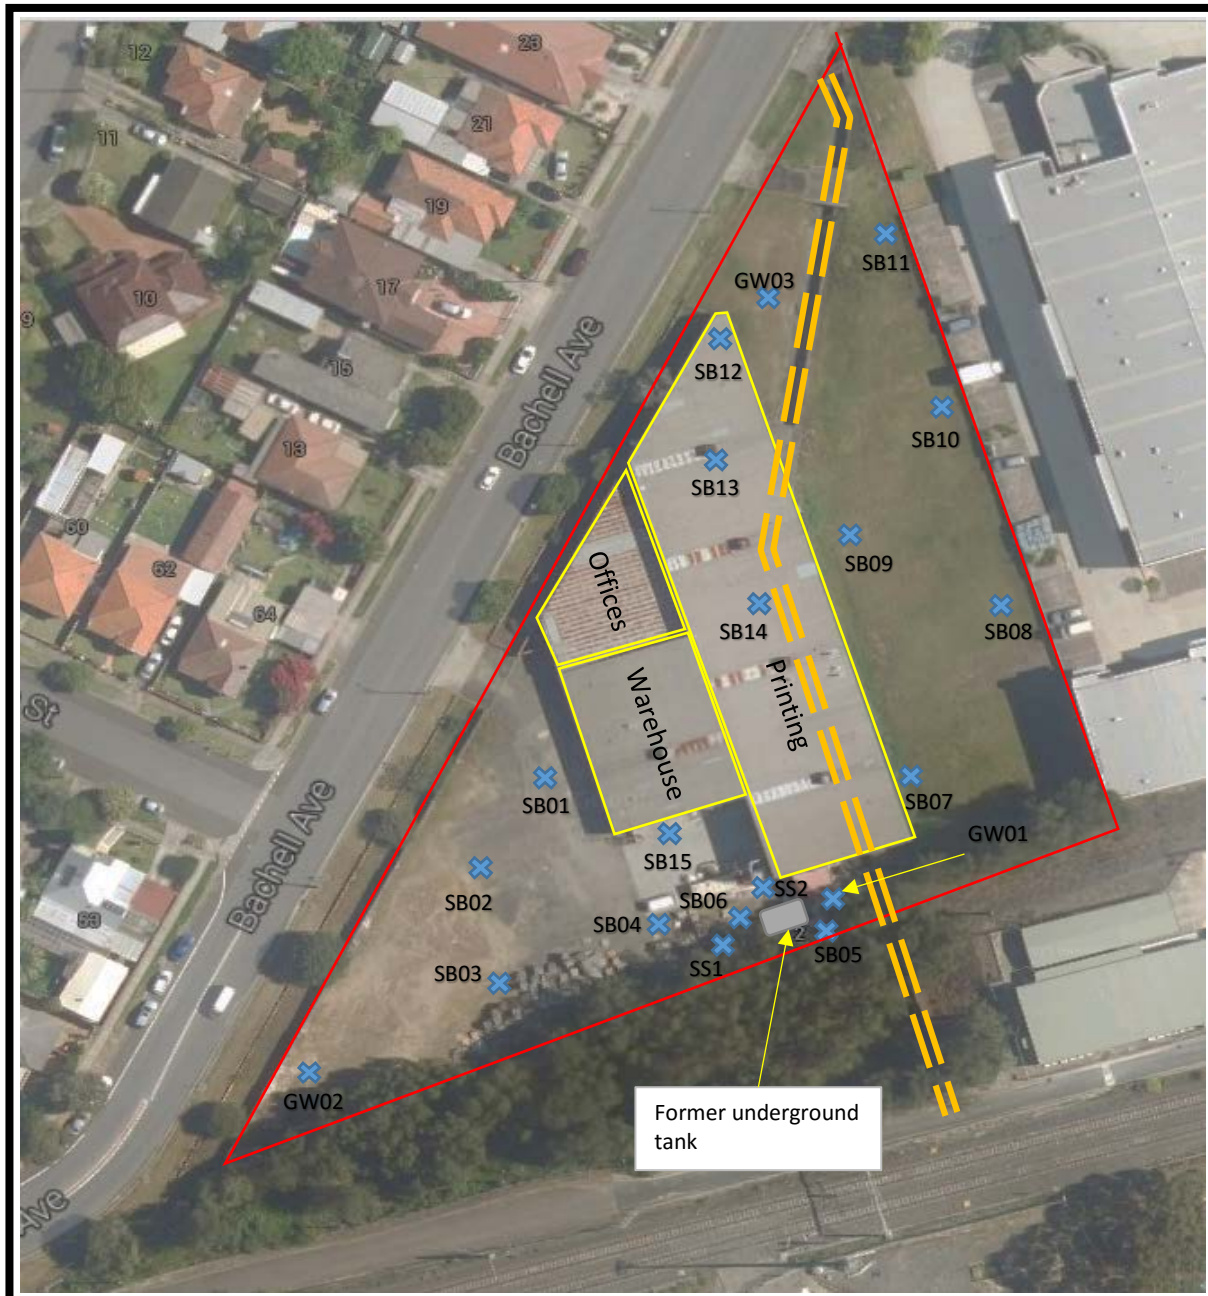
Client: Hallmark Construction Pty Ltd	Figure 2: Site Layout and Sample Locations
	Project: Phase 2 Investigation	
Project # SES_425	Location: 2 Bachell Avenue, Lidcombe NSW	Date: 27/11/2015

The scope of work included drilling and sampling of soil at 20 borehole locations, sampling of 3 groundwater wells, chemical analysis for a suite of contaminants at a NATA accredited laboratory, and preparation of a Phase 2 report. Analytical results were compared to relevant soil and groundwater criteria for high-density residential land use. A copy of the Phase 2 sampling locations and results summary tables are presented in **Attachment A**.

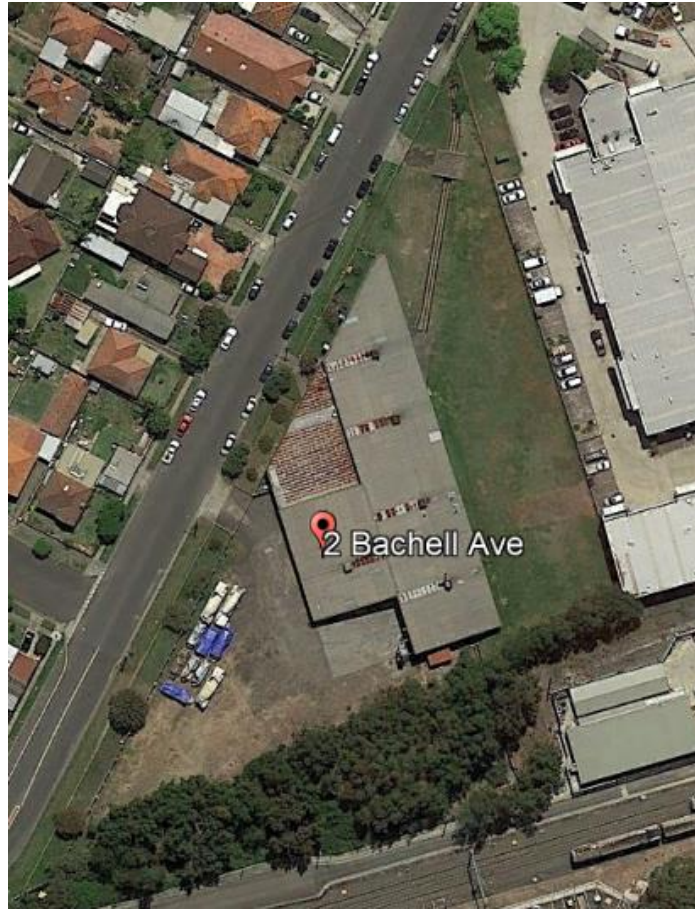
Month/Year	Details
Oct 2015	This image shows the site at the approximate time of the Phase 2 investigation. The western side of the building was being used as temporary storage of heavy vehicles (concrete trucks). The eastern side of the building was grassed, vacant and unused.
Oct 2016	At this time the laundromat business is operating within the building and a roof has been constructed over the southwest portion of the building to cover LPG tanks and external equipment. The western side of the building is sparingly being used for storage of materials by the lessee. The eastern side of the building remains grassed, vacant and unused.
Dec 2017	No major changes have occurred anywhere onsite other than greater storage of materials in the western lease area.

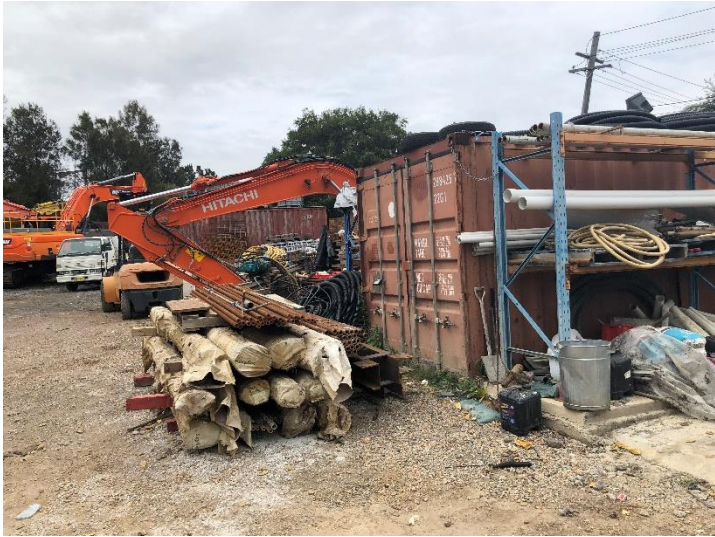
- Unsealed gravel surfaces. No oil stains or surface blemishes were observed.
- Heavy machinery storage, earthmoving equipment (25T excavators), related materials storage.
- No fibro cement materials or waste (potentially containing asbestos) was observed.
- Shipping containers, steel frames/scaffold, storage cages.
- Truck trailers, forklift, tip trucks, vehicle body parts.

Yard 1A stored items and ground cover.

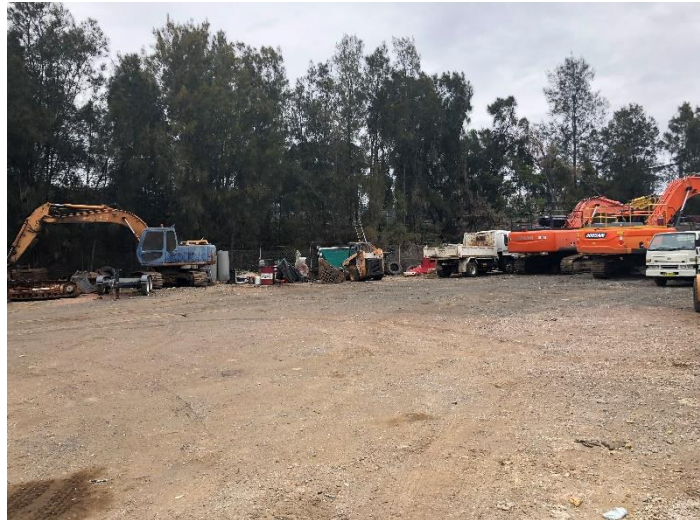
Yard 1B stored items and ground cover.

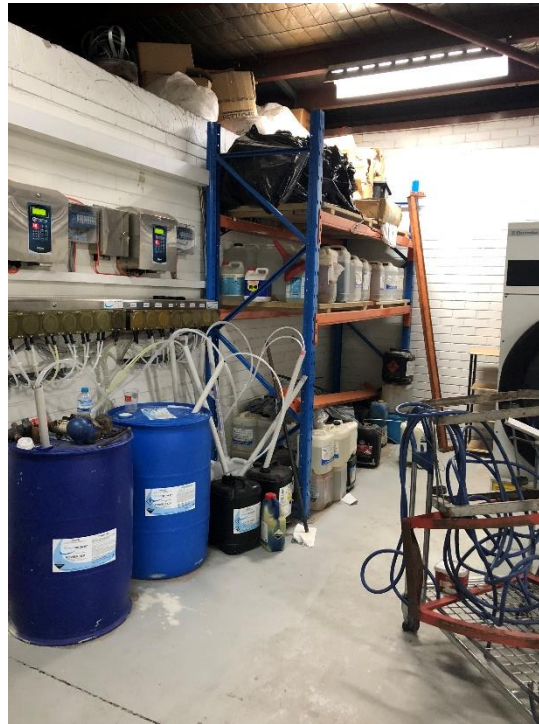
- All operations were located on sealed concrete. Interior concrete floors were painted. No surface stains/spills were observed.
- Interior of building comprised:
 - Office space
 - Dry cleaning units in north end of building
 - Washing machine units
 - Large washing unit
 - Ironing machines
 - Chemicals store on racks and on concrete ground. No bunding was observed in this area. Chemicals noted were 200L drums and 25L containers of caustic alkali additives, bleaches, hydrogen peroxide, and solvents and emulsifiers.
 - Materials handling/storage areas.
- Exterior of building comprised:
 - Chemicals dosing/dispensing unit.
 - Trade waste cooling pit and sewage discharge.
 - Materials handling/storage areas.
 - LPG tanks (x 4).

Chemical store within laundromat business.

- While commercial laundry/dry-cleaning activities have not been conducted at the site for any great length in time (i.e. approx. 2¹/₂ years), the operations are considered a high-risk activity under the SEPP55 Planning Guidelines¹. As such, the information gaps identified in this assessment relating to chemical use should be filled; and depending on the detail of this information, a limited program of soil sampling targeted at chemical stores and general site groundwater may be warranted.

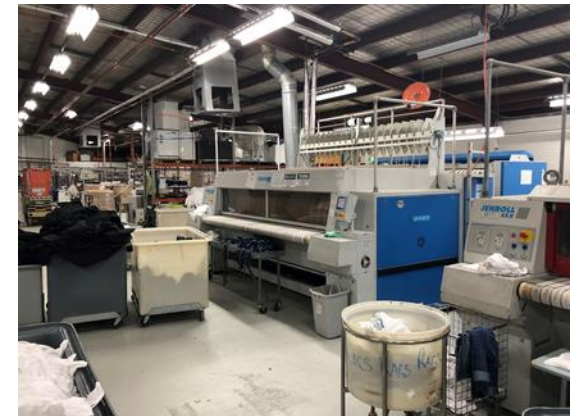
Interior of laundromat business.

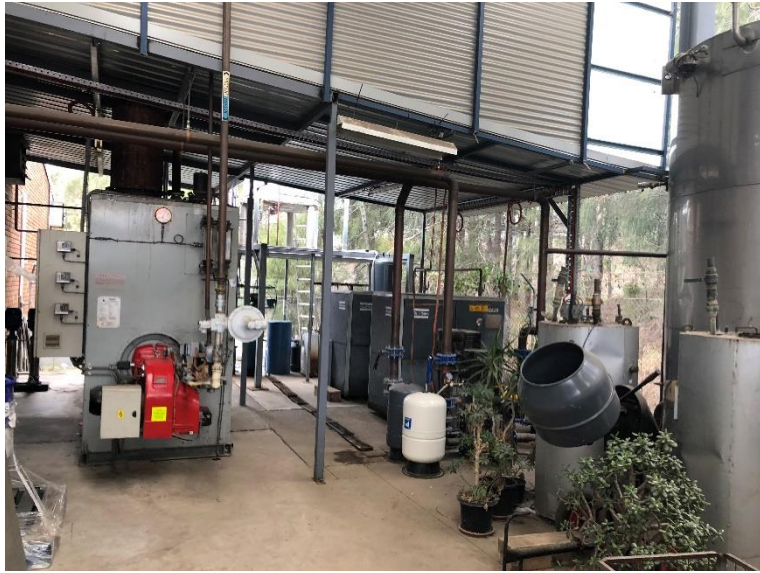
- Gas-fired boiler.

Exterior of laundromat building – boiler area.

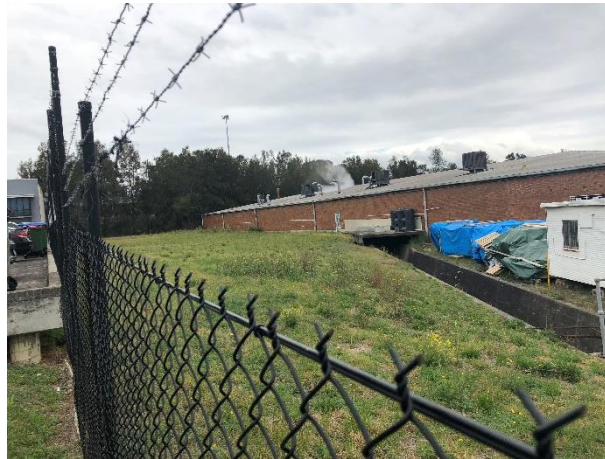
- Larger east side of stormwater channel remains unused/grassed vacant.
- Smaller west side of stormwater channel used to store construction equipment (e.g. site shed/portaloo, pallets, hording material, timbers, temporary fencing, LDPE lining, etc).

Yard 2 vacant land and temporary storage of construction materials.
