CUMBERLA	16 Memorial Avenue (PO Box 42) MERRYLANDS NSW 2160 T 02 9840 9840   F 02 9840 9734	PROJECT : PEMULWUY COMMUNITY GARDEN Corner Driftway Drive and Butu Wargun Drive, Pemulwuy			TITLE : LANDSCAPE MASTER PLAN		
CITY COUN	DX 25408 MERRYLANDS TTY 02 9840 9988	DRAWN :	CHECKED :	FILE :		SCALE :	As shown @ A3
	ABN 22 798 563 329	DESIGNED :	APPROVED :	DATE : March 20	22	SHEET :	1/1

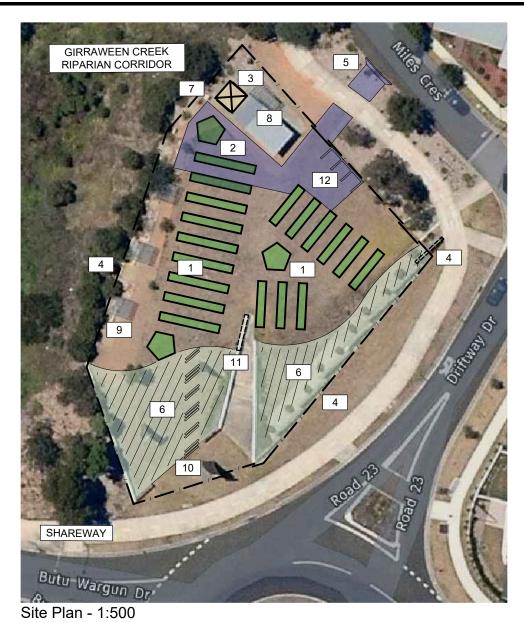
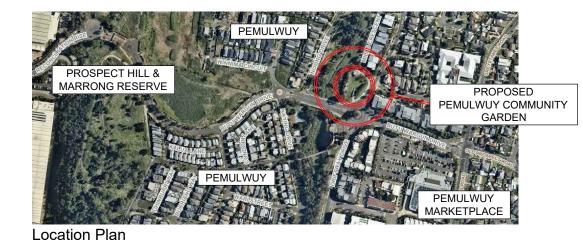
1	Typical Gard - concrete sle - wicking bed - 16 x rectang - 2 x pentago
	2	Accessible G - concrete sle - wicking bed - 2 x rectangu - 1 x pentago
	3	Storage Sheo - lockable me - skylight, adj - existing land
	4	Palisade Fen - tubular stee - sliding gate - sliding gate - remove x 1
	5	Vehicular Cro - concrete pa - continuous o
	6	Native Garde - edible and s - concrete sle
	7	Existing Drink - connect drip
	8	Existing Picni - review lighti
	9	Existing Perg
	10	Existing Scul
	11	Existing Feat
	12	Material Stora

Masterplan Feature	S						
len Beds eeper raised (0.5m) beds I water system gular mal							
arden Beds eeper raised (0.7m) beds water system ular nal							
tal tool storage (3.1m²) ustable shelving and double hinged doors ding pad							
ice I rod top and bottom (2.0m high) vehicular x 1 (3.2m wide) pedestrian x 2 (3.2m wide) section of blade wall							
ossover avement (3.2m wide) over utility and accessible areas							
en Beds specimen planting eeper steps							
king Fountain and Hose Tap Retained p line irrigation							
ic Table and Shelter Set Retained ing provision with sensor activation							
gola and Seating Retained							
ptures x 3 Retained							
ture Stairs Retained ver level section of blade wall							
age Bays x 3							
	(N)						
A3-LMP-01
